**STRATFORD/AVON RIVER ENVIRONMENTAL
MANAGEMENT PROJECT**

OPEN DRAIN IMPROVEMENT

Technical Report R-6

September, 1982

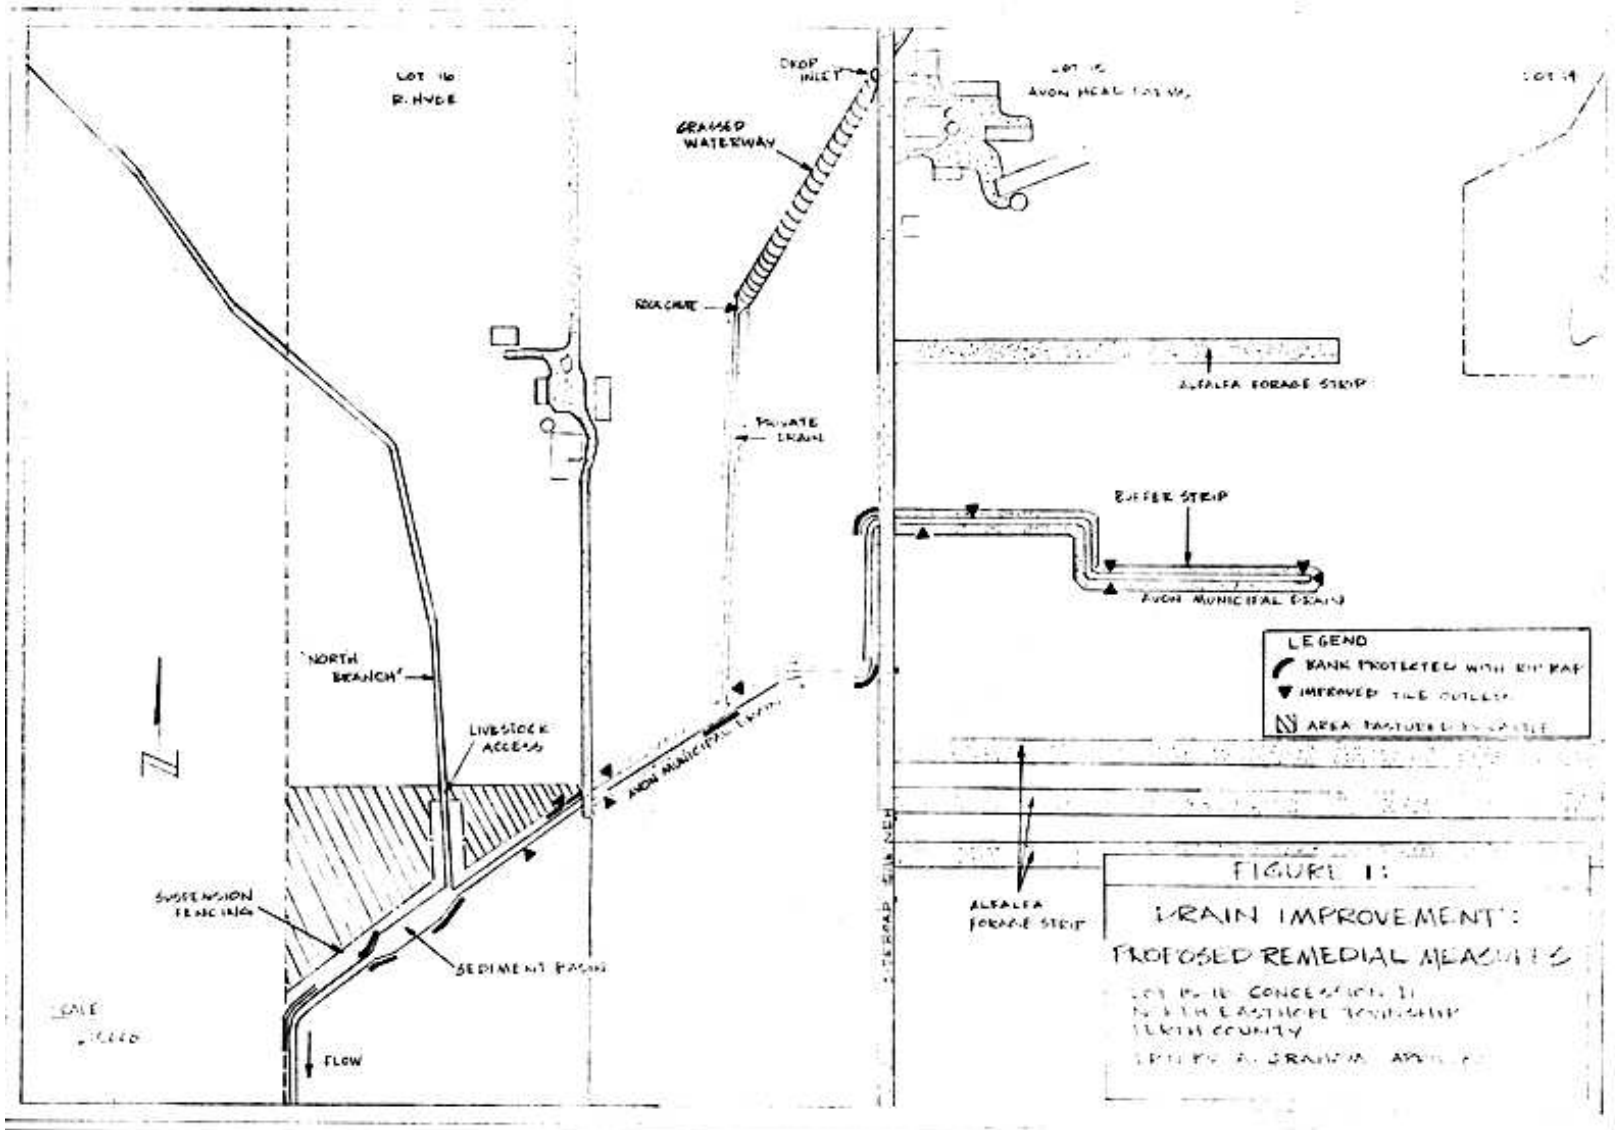
The Avon Municipal Drain originates on and flows as an open ditch easterly for about 1300 feet across Lot 15, owned by Avon Head Farms (see Figure 1). The year-round flow in the ditch is essentially fed by sub-surface tiles draining the adjacent cropland, and one tile which acts as an overflow from a nearby spring-fed pond. The surrounding fields are intensively cropped in corn and have been for several years. Overland runoff from the surrounding acreage was responsible for accelerated sheet and rill erosion which detached and transported noticeable amounts of topsoil and delivered it directly to the open watercourse. No vegetated buffer strips existed alongside the drain banks. Numerous problem locations were evident where the overland flows had concentrated before entering the open drain causing small gulleys to erode into the bank. These were commonly located where the sub-surface tiles also outletted.

In most cases, tile outlets were either improperly installed or lacking altogether. Both the outlets and the surrounding banks were subject to noticeable erosion. The drain itself was severely clogged with a 12 to 16 inch depth of collected sediment. This adversely affected the channel flow and the efficiency of the tile outlets. Except for these tile outlets, the ditch banks, in general, were well vegetated and appeared stable.

About one-half the distance across Lot 16, the Avon Drain passes through a pastured field where cattle had been allowed unrestricted access to the watercourse for a number of years. This practice had led to severe slumping and very unstable bank conditions. Scouring had taken place at the junction of the Avon Drain and the North Branch drain. Sediment deposition in the channel through this section of drain was estimated to be about 12 to 14 inches in depth. This could be largely attributed to bank erosion and to eroded material originating from upstream areas.

The remedial measures proposed for Lot 15 included: a bottom cleanout and adequate tile outlet protection for six subsurface tiles. This work would be completed in the fall of 1980.

Work to be completed on Lot 16 in the fall of 1980 included: the construction of a sediment basin in the channel of the Avon, a bottom cleanout, bank stabilization using rip rap where necessary, bank re-shaping, installation and protection of five tile outlets, and excavation of a limited livestock access on the 'North Branch' drain. Seeding of disturbed banks and levelling of the excavated spoil would be carried out in the spring of 1981. In addition, suspension fencing was to be erected on the north side of the Avon Drain to restrict livestock from the watercourse (Figure 2).

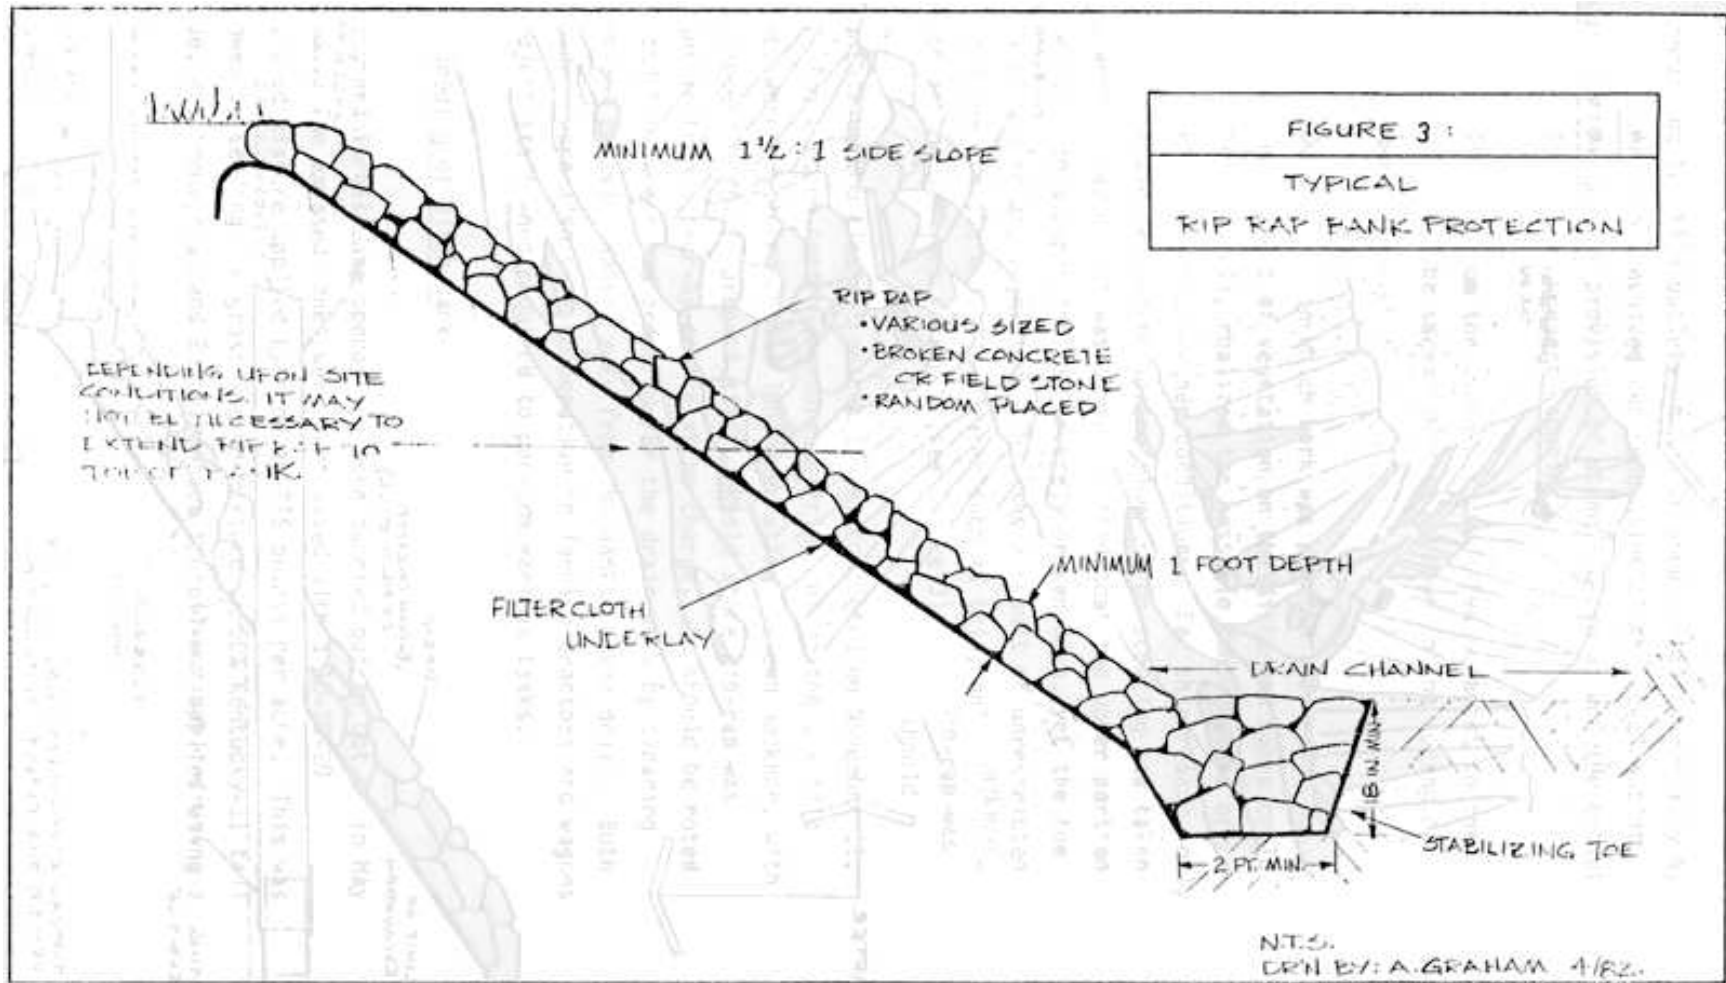
Where required, the drain banks were re-shaped to a stable side slope as indicated in Figure 3. Bank stabilization efforts included the re-grading of the bank and excavation of a toe to support and stabilize the stone rip-rap. Filter cloth was laid beneath the stone to prevent the washout of fine soil particles and thus maintain stability.

Due to the time of year in which work was done on the drain, no immediate establishment of vegetation on the disturbed banks could be achieved. Staff fully realized the possible consequences of erosive winter and spring weather conditions. For this reason, only those sections of bank where severe slumping or scouring had taken place were reshaped. It was common to find that the upper portion of the bank had slumped and was severely broken down, yet the toe was quite stable and vegetated. This was a result of unrestricted cattle access to the drain. In cases such as this, only the upper portion of the bank was reshaped (see Figure 3).

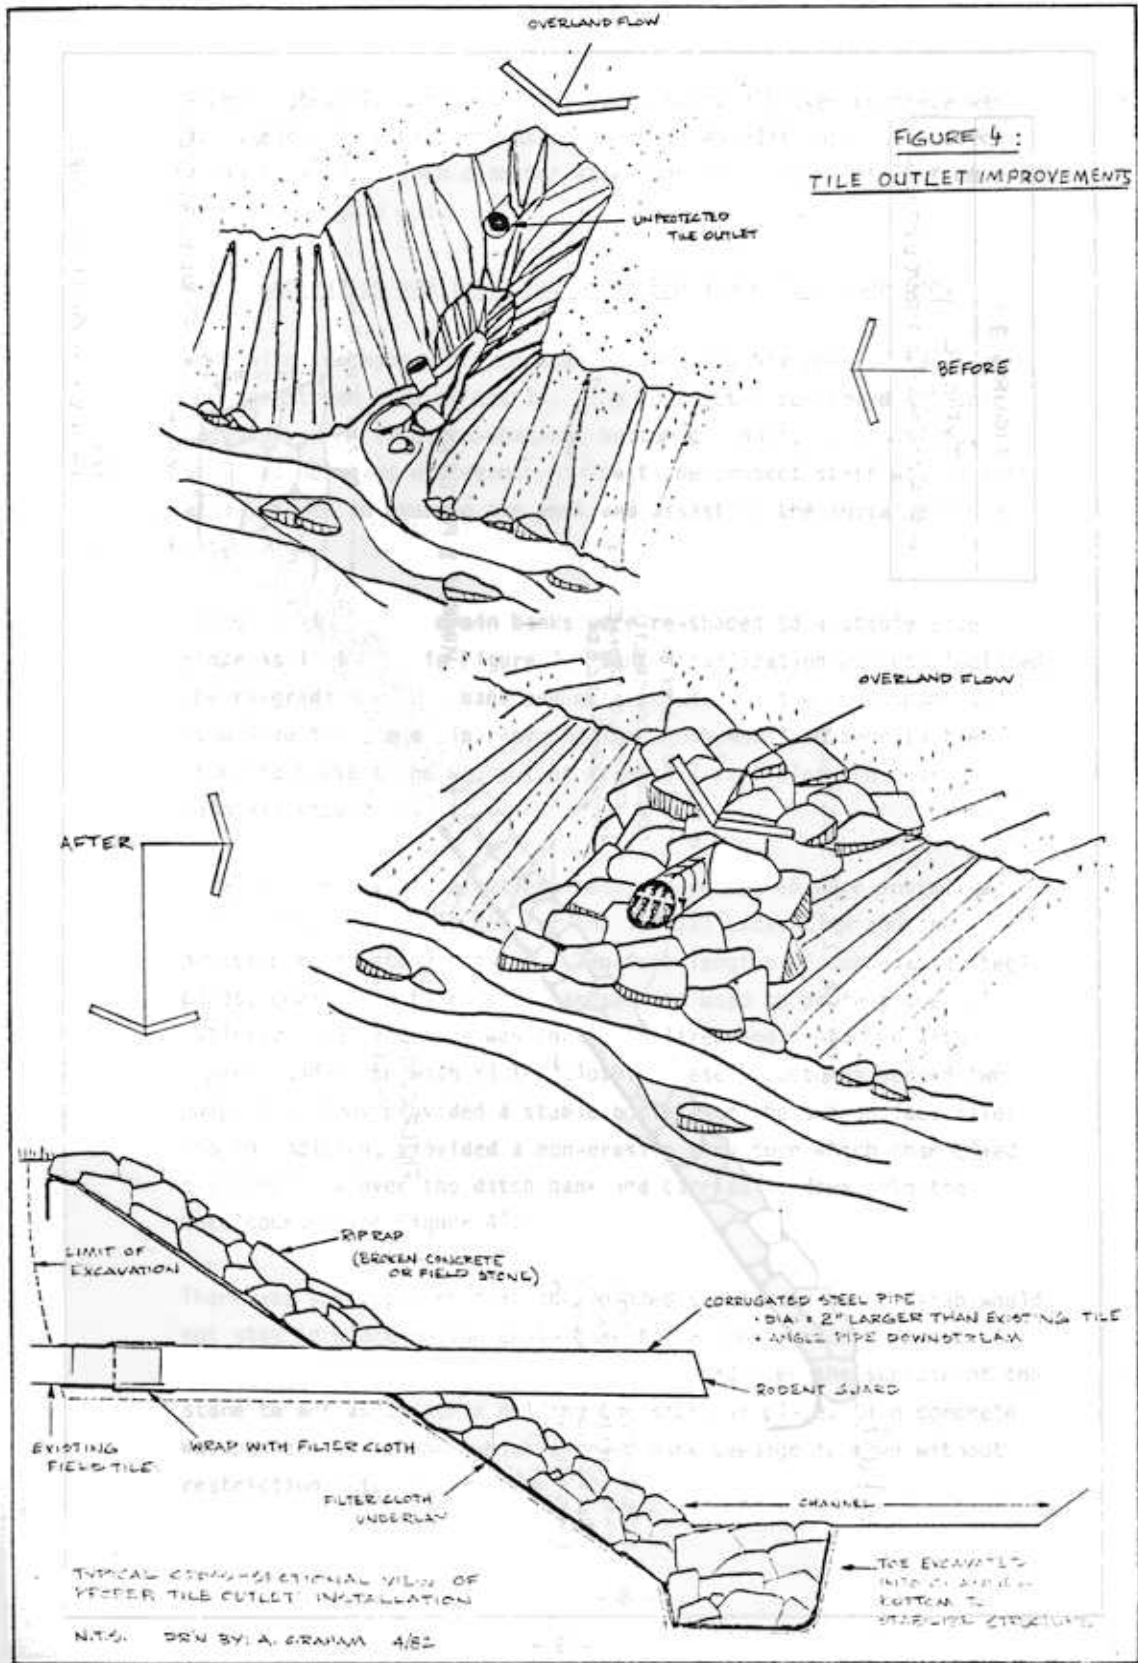
Three of the five tile outlets required on Lot 16 were installed using of the hydraulic hoe for the initial excavation and the positioning of stone rip-rap. Ten-foot lengths of corrugated steel pipes, equipped with rodent guards, were used to protect the outlets. The structure was then stabilized and protected with rip-rap underlain with filter cloth. These structures served two purposes. They provided a stable outlet for the sub-surface tiles and in addition, provided a non-erosive structure which channelled overland flow over the ditch bank and carried it down into the watercourse (see Figure 4).

There was some concern that the rounded stone used for rip-rap would not stay in place on the drain bank for a long period of time. A sloppy concrete mixture was therefore poured over the surface of the stone to act as a matrix holding the stone in place. The concrete was poured in a manner which allowed bank seepage to move without restriction into the drain.
