**STRATFORD/AVON RIVER ENVIRONMENTAL  
MANAGEMENT PROJECT**

**GULLY EROSION CONTROL  
DEMONSTRATION PROJECT**

**Technical Report R-16**

September, 1982

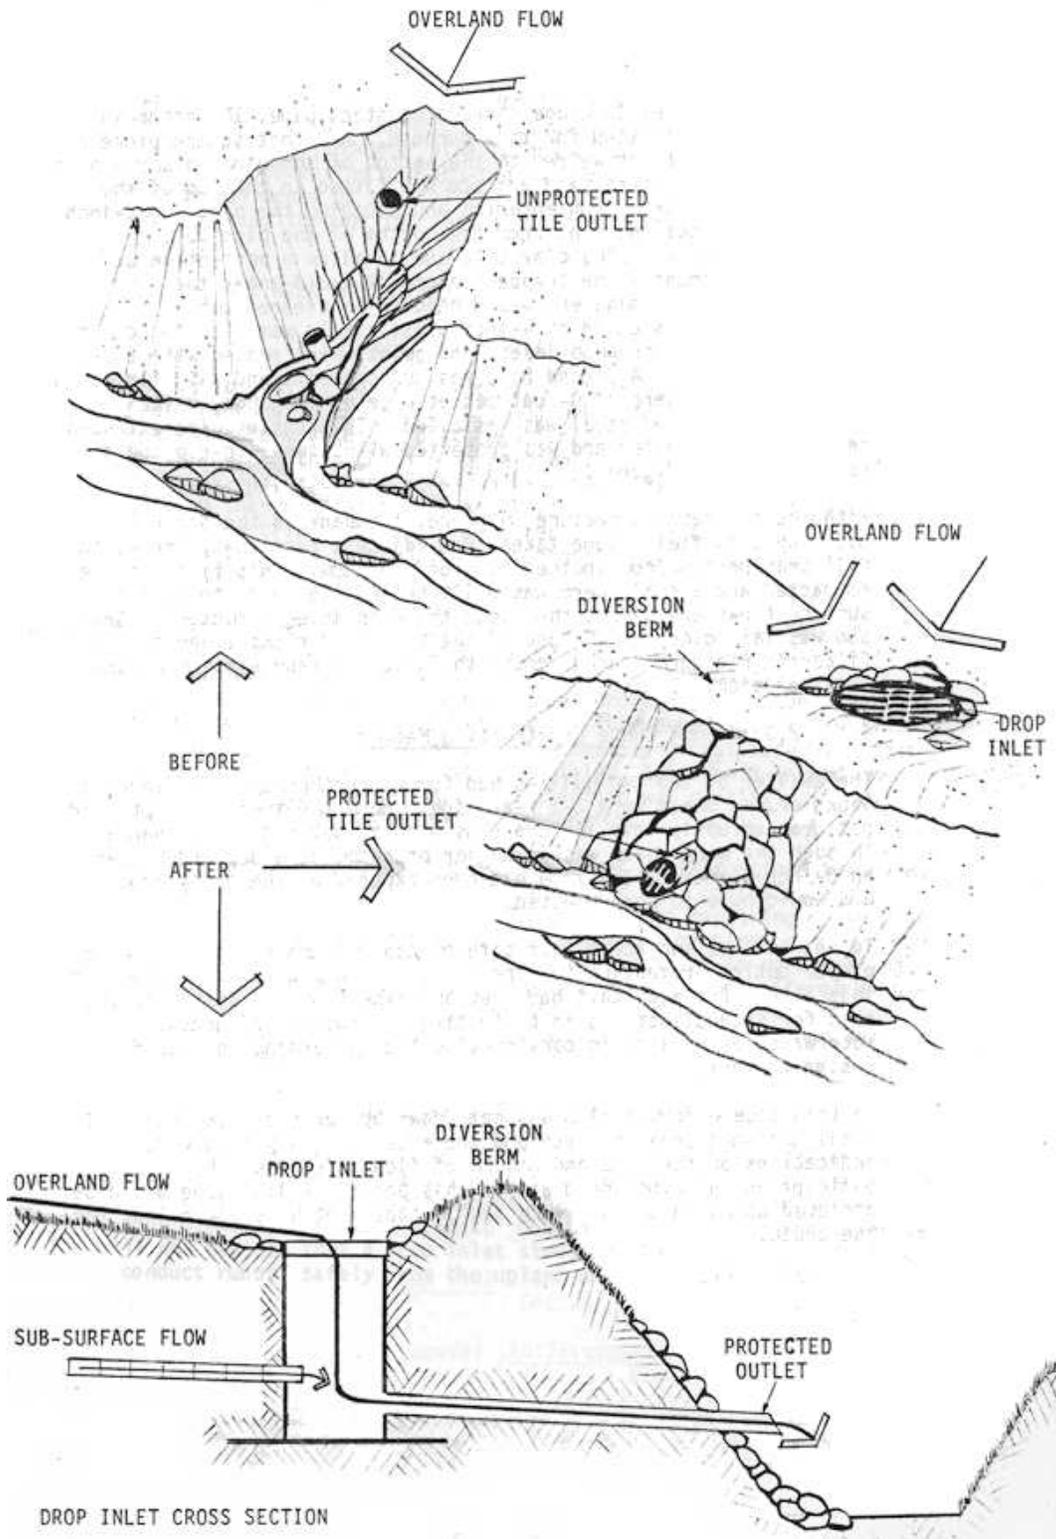
Since the characteristics of the two gullies differed, different methods were used to stabilize them and control erosion. The larger of the two gullies occurred where the banks of the drain were approximately 6 feet in height. Due to this abrupt change of grade it was decided that a drop inlet structure would be best suited to conduct runoff safely from the upland area into the drain.

**Figure 1:** Drop Inlet Structure

A 4-foot section of 16-gauge corrugated steel pipe, 18 inches in diameter, was outfitted for this purpose. A 3-foot square piece of sheet metal was first welded to the bottom of the pipe to serve as a base for the structure, and a grate was fitted to the top of the inlet to keep debris from entering and clogging the pipe. A 5-inch hole was then cut one foot from the bottom of the pipe to accommodate the existing clay tile and to allow a percentage of suspended sediment to be trapped before it could enter the watercourse. This sediment would need to be cleaned out periodically. A section of 4-inch plastic tile was used to connect the clay tile to the drop inlet, and joints were sealed with a concrete mixture. A second hole was cut opposite and slightly below the tile inlet where a 10-foot outlet pipe of 20-gauge, 6-inch diameter corrugated steel was installed. This outlet pipe extended into the drain proper and was protected with stone rip-rap and a splash pad (see Figure 1).

With the completed structure in place, the bank of the drain was built up with field stone taken from adjacent fence rows, and earth fill transported from another part of the farm. This fill was then compacted and a small berm was built behind the inlet to contain surface flows and direct them into the drop inlet structure. Grass sod was laid over the surface of the berm, and rocks underlain with filter fabric were placed around the inlet to reduce scouring and local erosion.

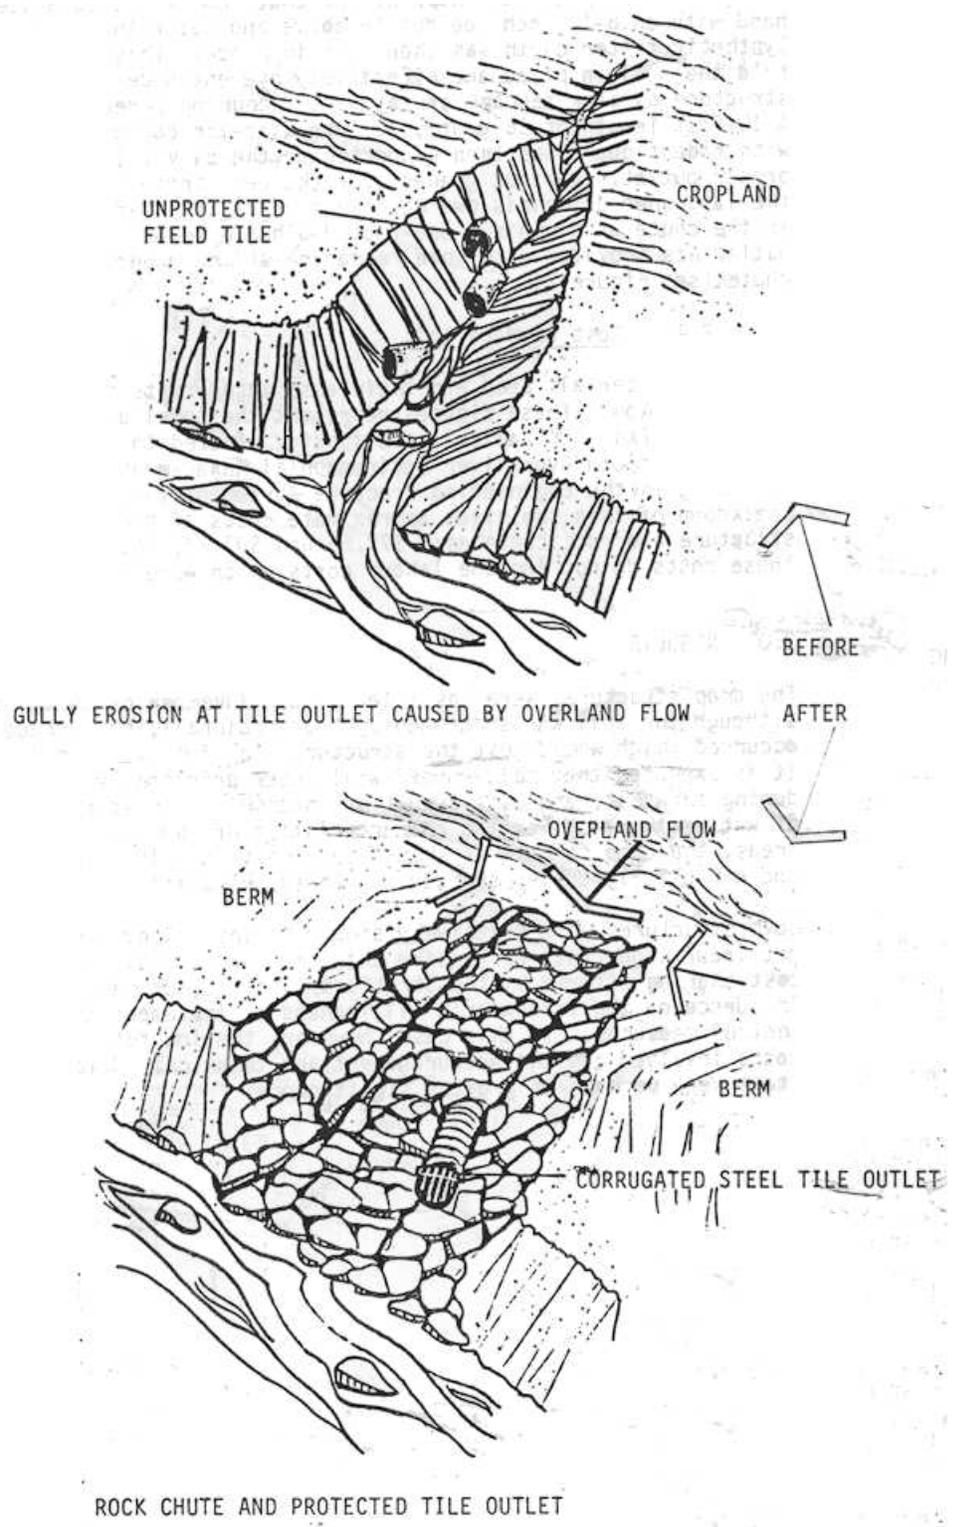
The smaller of the two gullies had formed further upstream where the banks of the drain were 2-3 feet high. Here the surface runoff did not drop abruptly into the drain as before, but had cut a channel through the bank which was in danger of becoming wider and deeper. An 8-inch diameter clay tile had been exposed by the gully erosion and would have to be protected.

**FIGURE 2:** Rock Chute Structure

The general trapezoidal shape of the chute was first excavated by hand with an 8-12 inch toe dug in above and below the chute. Synthetic filter cloth was then laid in place. This material would hold the soil in place and effectively prevent undermining of the structure by bank seepage and by water scouring beneath the rocks.

A 10-foot length of 16-gauge, 10-inch diameter corrugated steel pipe with rodent guard was then connected to the clay tile to serve as a proper outlet. Various grades of rocks were brought to the site by the landowner using his own equipment. Project staff placed these in the chute at a minimum one-foot depth. A splash pad for the tile outlet was provided with some regrading at the upper end of the chute (see Figure 2).
