BioMAP Report SWR-2
Ministry of Environment and Energy
Southwestern Region
Water Resources Assessment Unit
985 Adelaide St. South
LONDON, Ontario N6E 1V3

**ENVIRONMENTAL ASSESSMENT OF THE
TEESWATER RIVER AT THE VILLAGE OF
TEESWATER, BRUCE COUNTY**

J. D. Westwood and Mike Johns

November 1993

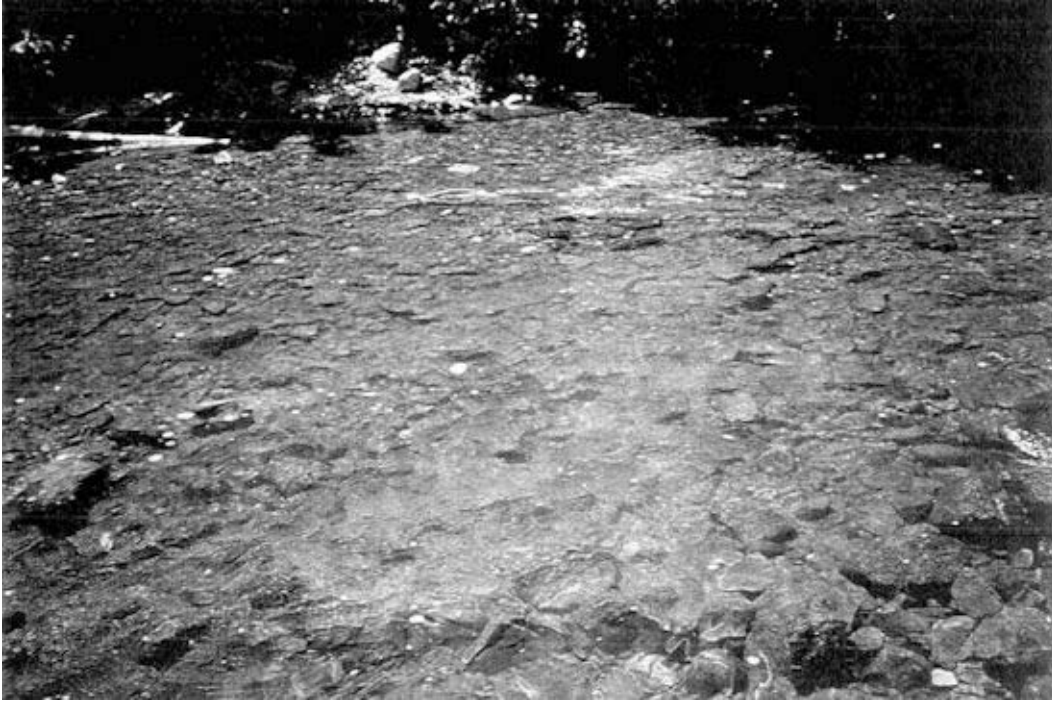
At Site 1, the substrate was fairly clean. There was sparse diatom growth and *Cladophora* stubble on the larger cobble and rocks which were moderately silted. The water was very clear with no odour. On July 26, the water temperature was 23°C and the conductivity was 490 µmho/cm³.

There were no rooted plants at Site 1, however there was sparse *Cladophora* stubble and some moss and diatom growth on the larger rocks (Figure 4). At Site 2, below the STP discharge, watercress was present along the stream margin and healthy growths of moss were present in the riffles (Figure 5). At Site 3 dense beds of the macrophytes *Elodea* and *Potamogeton* were noted in riffle areas. Nuisance growths of *Cladophora* appeared just upstream of site 3 and continued downstream for at least 2 km. Frond lengths averaged approximately 4 - 5 cm at Site 3 and increased in length to more than 200 cm at Site 4. At Site 4, large mats of *Cladophora* drifting from upstream, were accumulating in nearshore areas, rocks and bridge abutments. Rooted aquatic plants (*Elodea* and *Potamogeton*) were well established in this area.

Figure 4: Substrate at biological sampling Site 1 (upstream control).

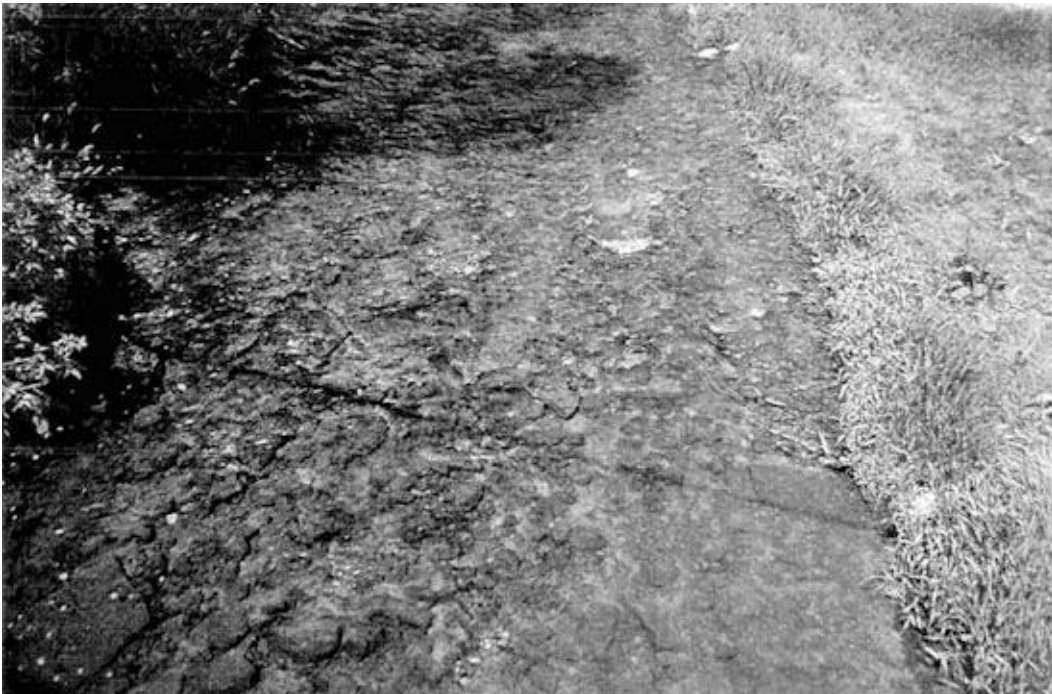
At Site 2, siltation was minimal and the water was clear and odourless. On July 26, the water temperature was 23°C and the conductivity was 495 µmho/cm³.

Figure 5: Substrate at biological sampling Site 2.

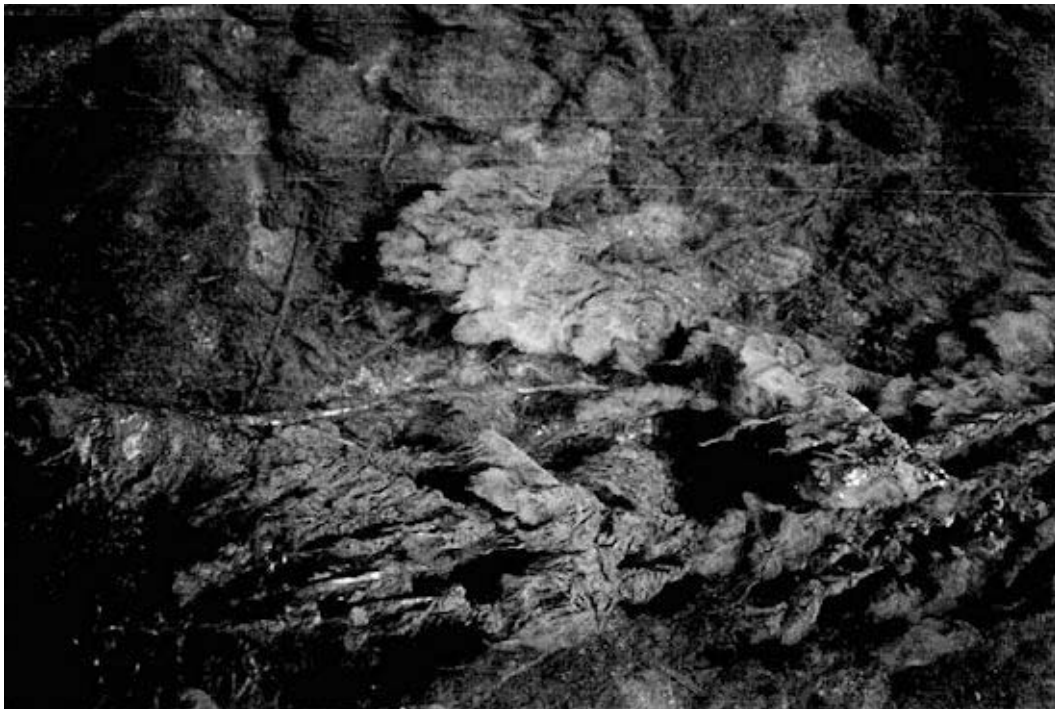
Site 3 supported nuisance growths of the filamentous bacteria *Sphaerotilus*. Severe siltation occurred in areas of dense vegetation and bacteria growth. The water was clear but had a foul, sour odour. On July 28, the water temperature was 23°C and the conductivity was 500 µmho/cm³.

Severe growths of sewage fungus, the bacterial slime *Sphaerotilus*, originated from the cooling water and boiler blowdown pipes discharging water into the river from Gay Lea Foods Cooperative Limited. These discharge pipes were located on the north side of the river, between County Road 16 and Highway 4. The greyish-white slime growths fouled the inside of the discharge pipes and fouled the river bottom downstream of these discharges in a defined plume along the north side of the river (Figure 6). Complete fouling of the river bottom with bacterial slime occurred in the vicinity of the Highway 4 bridge. The stream substrate, including algae and rooted plants, was completely fouled with a layer of bacterial slime for a distance of approximately 500 m downstream of the Highway 4 bridge (Figure 7).

Figure 7: Substrate at biological sampling Site 3 fouled with *Sphaerotilus*.

occurrence of *Sphaerotilus* also indicates poor water quality conditions. *Sphaerotilus* grow as chains of cells enclosed in tubular sheaths and colonize all submerged surfaces. It is a very long, fine, filamentous, slime producing bacteria which, when healthy, is usually white in colour. *Sphaerotilus* is typically found in rivers below sources of organic pollution.

It often thrives downstream from treated and untreated domestic sewage, and untreated industrial effluent, particularly food and drink industries (Curtis 1969). *Sphaerotilus* thrives best in a continuous source of nutrients. The oxygen consumption of this nuisance bacteria can be 10 to 20 times greater than that of other normally occurring macrophytes. *Sphaerotilus* easily sloughs off and drifts downstream. Drifting *Sphaerotilus* may reattach and continue growing, or may accumulate in pool areas where it decomposes and produces a foul odour. In bloom proportions, it dominates the substrate and smothers fish eggs and aquatic fauna. Commercial and sport fishing can be affected by the fouling of nets and lines (Curtis 1969).

1. The Gay Lea Foods Cooperative Limited should immediately address the control of nutrients, organics and bacteria from their processing facility in the village of Teeswater. To protect water quality in the Teeswater River, phosphorus levels from the sewage treatment plant should be less than 0.5 mg/L during the growing season and 1.0 mg/L or less during the winter. BOD₅ and suspended solids levels should not exceed 15 mg/L. Discharges from the plant during ice-free periods (May to November) should not have *E. coli* concentrations exceeding 200 per 100 mL and *Pseudomonas aeruginosa* exceeding 0 per 100 mL.

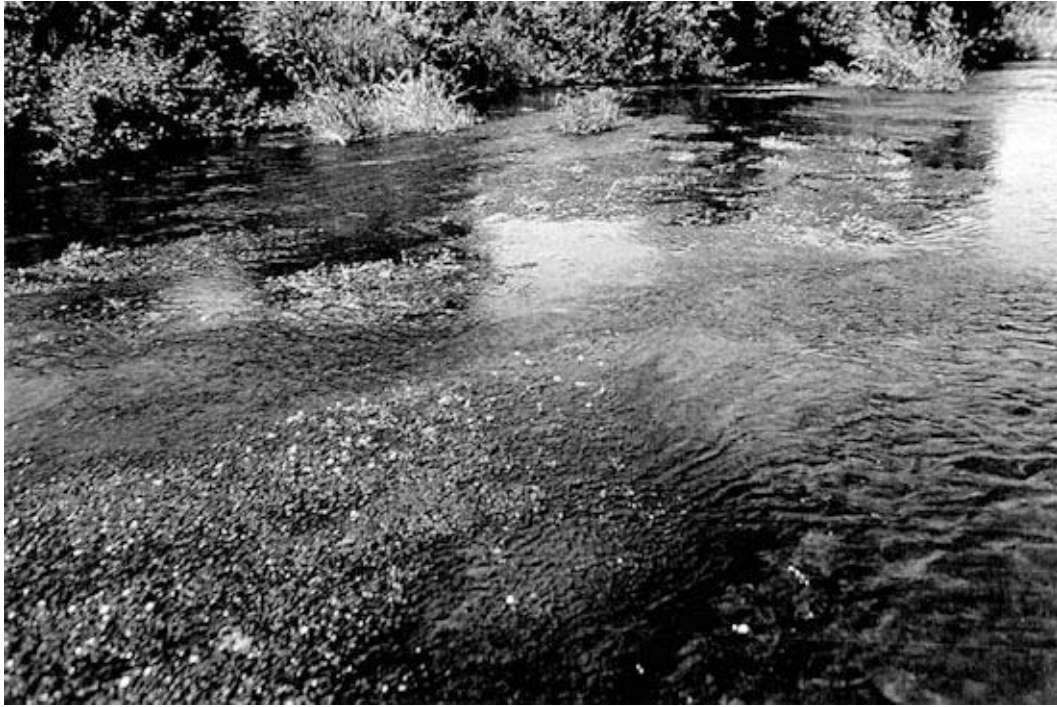
The dense, luxuriant beds of *Elodea* and *Potamogeton* which occurred at site 3 and downstream (Figure 8) are indicative of eutrophic conditions. These plants require abundant nutrients (namely phosphorus) and require clear waters to exist. The nuisance growths of *Cladophora* observed at site 3 and downstream (Figure 9) also indicate enriched water quality conditions. *Cladophora* is a filamentous green alga that thrives in nutrient rich waters. It frequently reaches nuisance proportions downstream of intensive agricultural areas and nutrient rich discharges. Unlike *Sphaerotilus*, it requires sunlight and a solid substrate to thrive. As a result of increased photosynthesis and respiration by *Cladophora* severe oxygen fluctuations occur daily. During the decay phase oxygen demand increases, thereby creating additional stress to aquatic organisms. Dense *Cladophora* growth dominates the substrate and causes siltation as water velocity is reduced through thick mats. *Cladophora* blooms most often occur as a result of human activity and can cause severe alterations to the previously existing aquatic habitat (Westwood and Johns 1992).

Figure 8: Profuse Macrophytes between biological sampling sites 3 and 4.

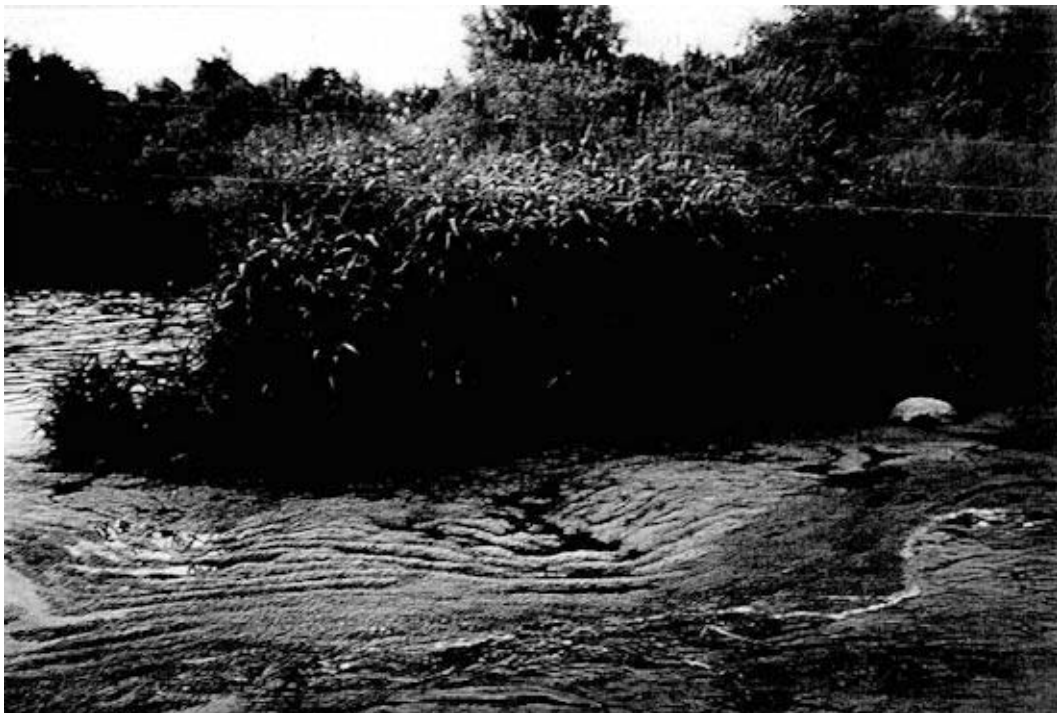
The composition of the benthic community at Site 4 is similar to Site 1, and reflects nutrient enriched conditions. The greater richness in species such as clams, snails, beetles, crayfish and amphipods likely reflects the wider range of habitats available at this location. The occurrence of macrophytes and *Cladophora* suggests that this site is more enriched than site 1. The lack of sewage fungus indicates that conditions have recovered from those at site 3.

Figure 9: Large mats of *Cladophora* at biological sampling Site 4.
