**Lake
Simcoe
Environmental
Management
Strategy**

**Assessment and Control of Duckweed in the
Maskinonge River, Keswick, Ontario.**

Technical Report: Imp. B.6

**ASSESSMENT AND CONTROL OF DUCKWEED
IN THE MASKINONGE RIVER,
KESWICK, ONTARIO**

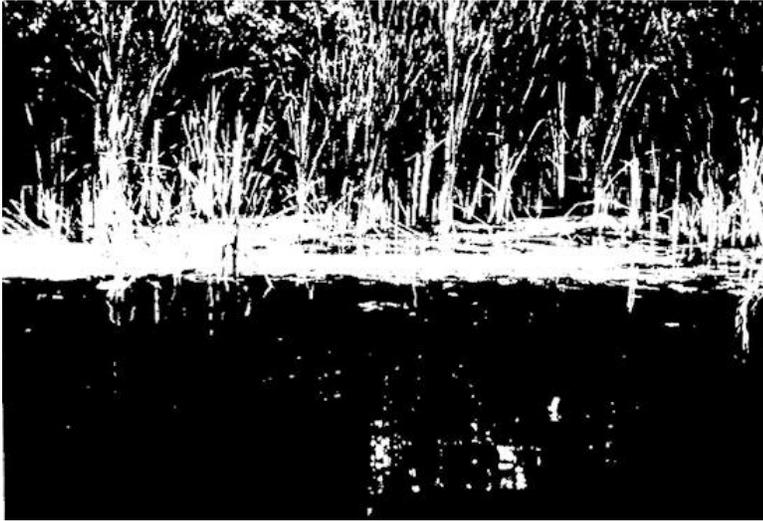
Plate A. Duckweed seed nursery area in cattails. Herbicide treatment was carried out at this site.

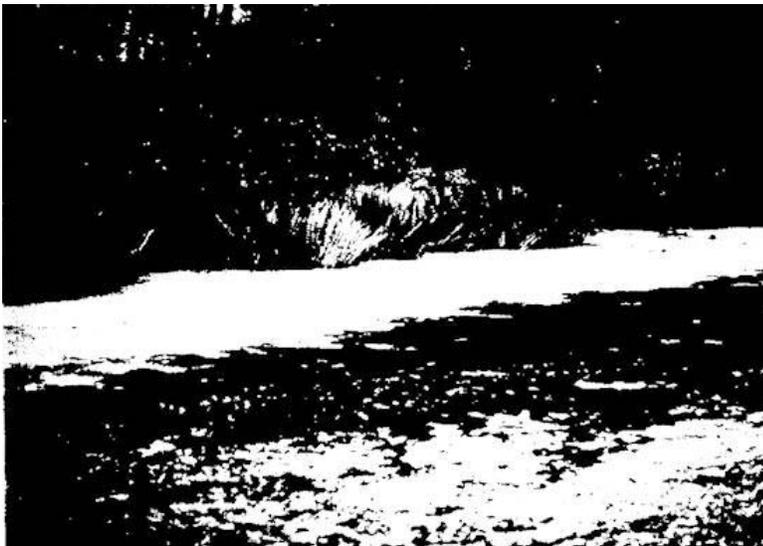
Plate B. Duckweed growth in the same vicinity of Plate A, two weeks following herbicide treatment. Note the extension of the duck-weed mat toward the middle of the channel and the free-floating duckweed moving down-stream.

The recommended application rate of Reglone A to control duckweed growth is 22 L/ha (OMAF, 1988). Thus in an estimated treatment area on the Maskinonge River of 0.5 ha, 11 L was required in one treatment to provide control. However, since more than one treatment was required to keep the duckweed growth under control a total of 41 L was used during the program. Unlike rooted macrophytes, duckweed is subject to dispersal in the river and as a result, viable duckweed could be dispersed to those areas where treatment had occurred and continue to grow. Sites where duckweed proliferated, received as many as five treatments to control growth (Figure 1; plate B)

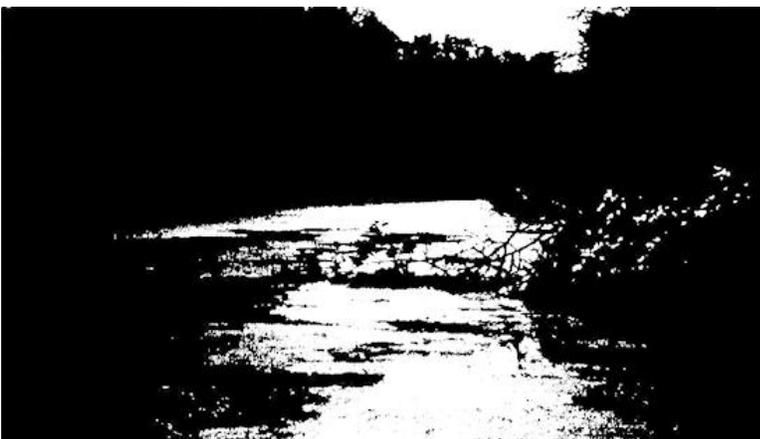
Plate C. Duckweed growth (100% cover) above the forks of the Maskinonge River. This section was not treated with herbicide.

Complete coverage of duckweed did develop upstream of the river forks above the Woodbine Road bridge, in areas adjacent to and downstream from the sod farms Figure 1; plate C). This growth provided a continual source of duckweed drift to the lower reaches of the river. This section of the river was not treated because water from the river was used for irrigation of the sod crop. This constraint was agreed to with the owner.

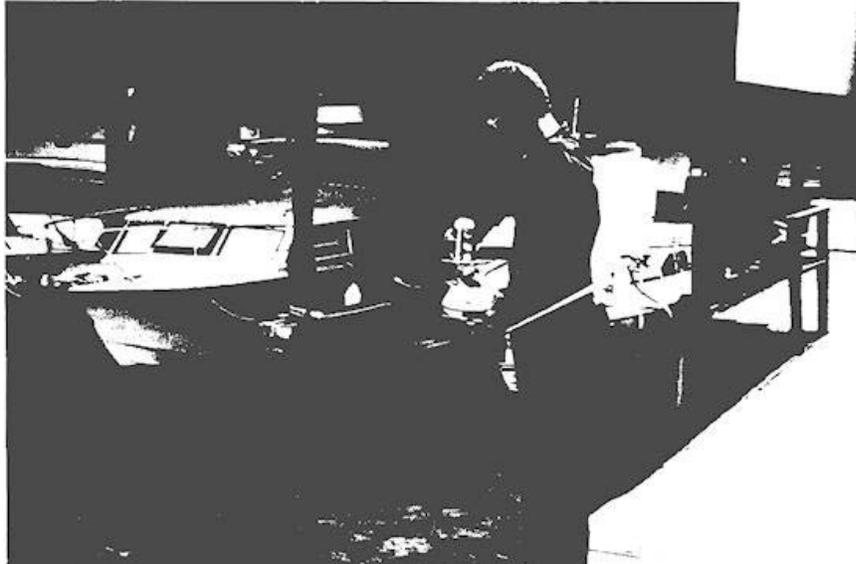
Plate E. Herbicide application at Keswick Marine using a backpack sprayer.

The herbicide was applied, as per label instructions, directly to duckweed growth using a back pack sprayer (Figure 1; plate E). While some spraying was done from shore, the majority of spraying was conducted from a small boat. A second person assisted the herbicide applicator by operating the boat. Applications were made on

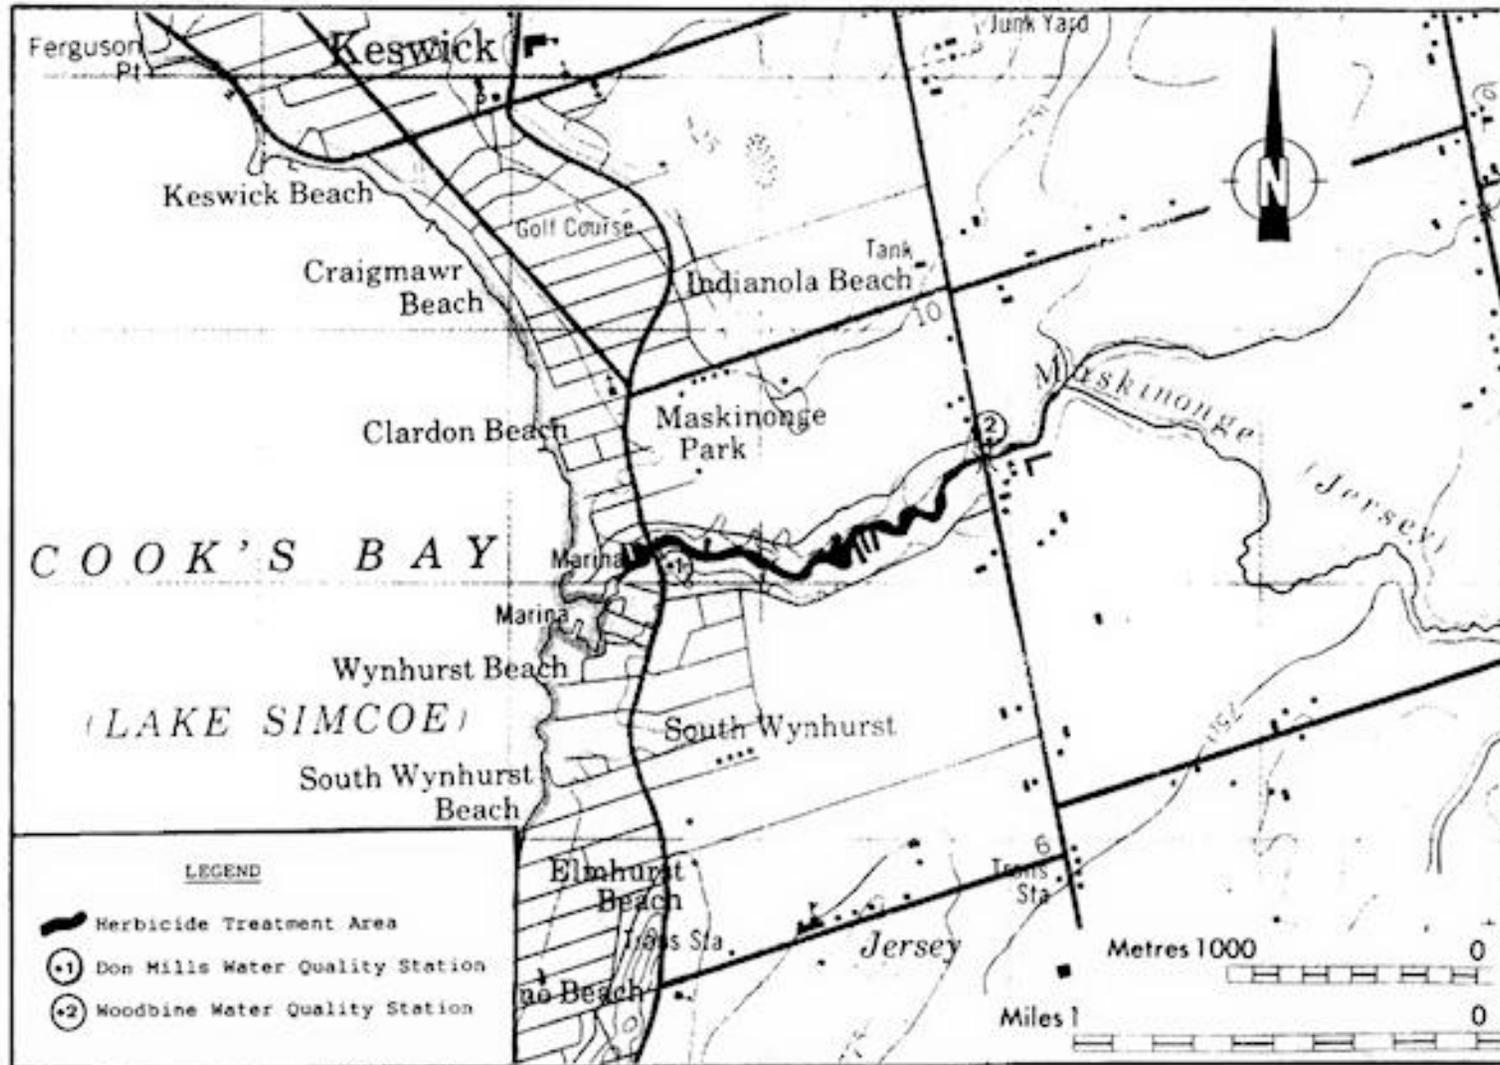
Figure 2. Maskinonge River herbicide treatment area and location of Woodbine and Don Mills water quality monitoring stations.

Water quality data from 1982 to 1988 from two sites on Maskinonge River (Don Mills station and Woodbine station) were assessed (Figure 2). As well, water quality data from the Black and Holland Rivers were evaluated to provide a comparison of water quality as it may affect duckweed growth. This data analysis provided an indication of the amount of phosphorus and nitrogen in the water that would be available for plant growth. It was anticipated that any developing trends or dramatic increases in nutrient availability in the water might be reflected by an evident increase in duckweed growth.

Residences along the Maskinonge River between Woodbine Avenue and Don Mills were connected to a sewer system in 1985. Therefore, possible nutrient contributions from septic tank systems that were functional prior to 1985 is no longer a potential source of nutrient enrichment of the river. As well, water quality data provides no evidence of increased nutrient levels at the sampling site downstream from the residential area (Don Mills station Figure 2).

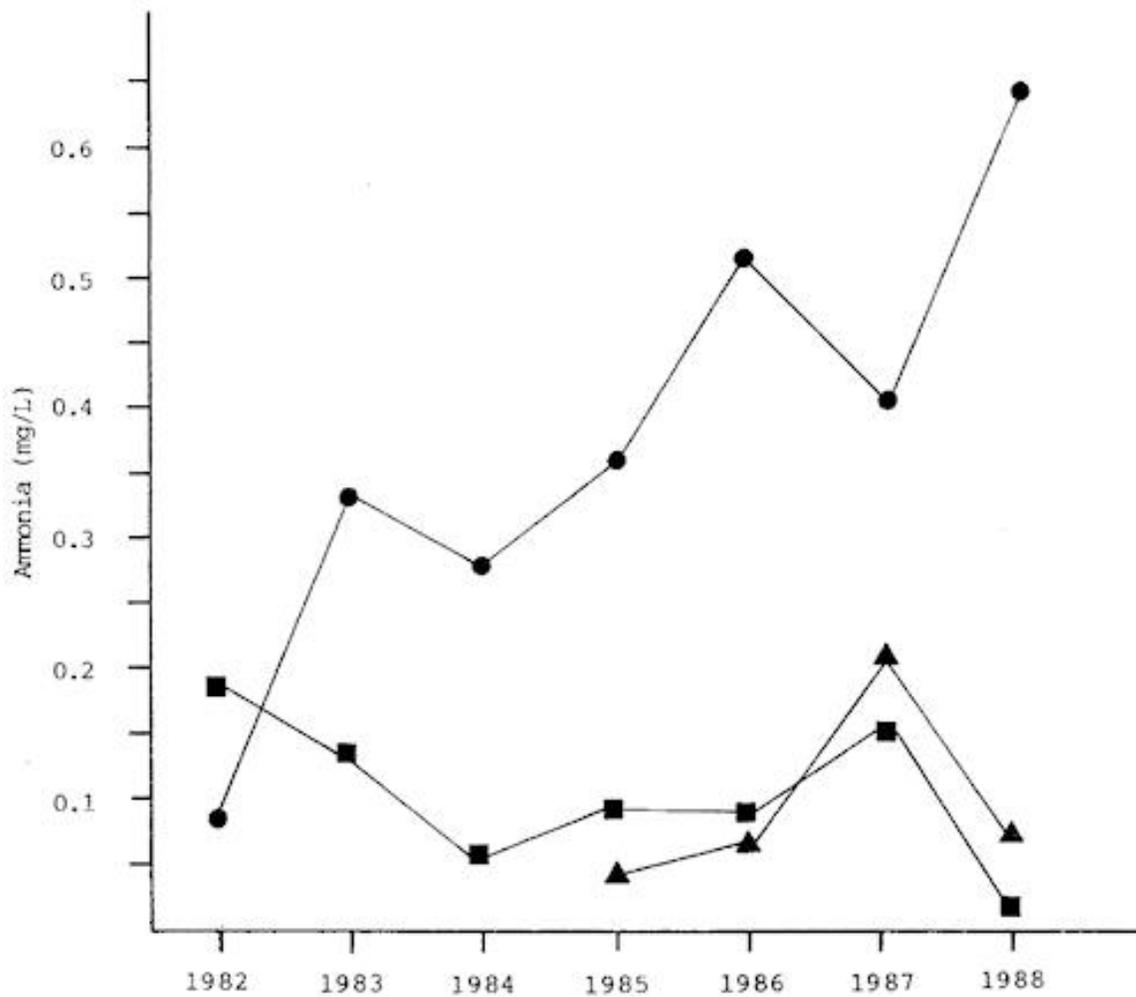
Figure 3. Ammonia concentrations from 1982-1988 in the Maskinonge River at the Woodbine Station(▲) and Don Mills Station(■), and the Holland River(●).

Ammonia increased from 0.057 to 0.210 mg/L from 1986 to 1987 at the Woodbine station and increased from 0.081 to 0.154 mg/L at the Don Mills station from May to September Figure 3. Nitrates increased from 0.186 mg/L in 1986 to 0.326 mg/L in 1987 at the Woodbine station decreased from 0.156 to 0.05 mg/L at the Don Mills station from 1986 to 1987, respectively (Figure 4). Phosphorus concentration at the Woodbine station increased from 0.130 to 0.237 mg/L from 1986 to 1987, however there was no increase in phosphorus at the Don Mills station from 1986 to 1987,

In 1988, the nutrient levels in the Maskinonge River had decreased significantly from 1987. Ammonia decreased to 0.072 mg/L Figure 3), nitrates decreased to 0.045 mg/L Figure 4), and phosphorus decreased to 0.162 mg/L Figure 5 at the Woodbine station. A decrease in ammonia and nitrates 0.016 and 0.020 mg/L, respectively was also observed at the Don Mills station in 1988. Phosphorus increased by approximately 50% at the Don Mills station from 1987 to 1988. Corresponding to decrease in nutrient availability duckweed growth was reduced in 1988.

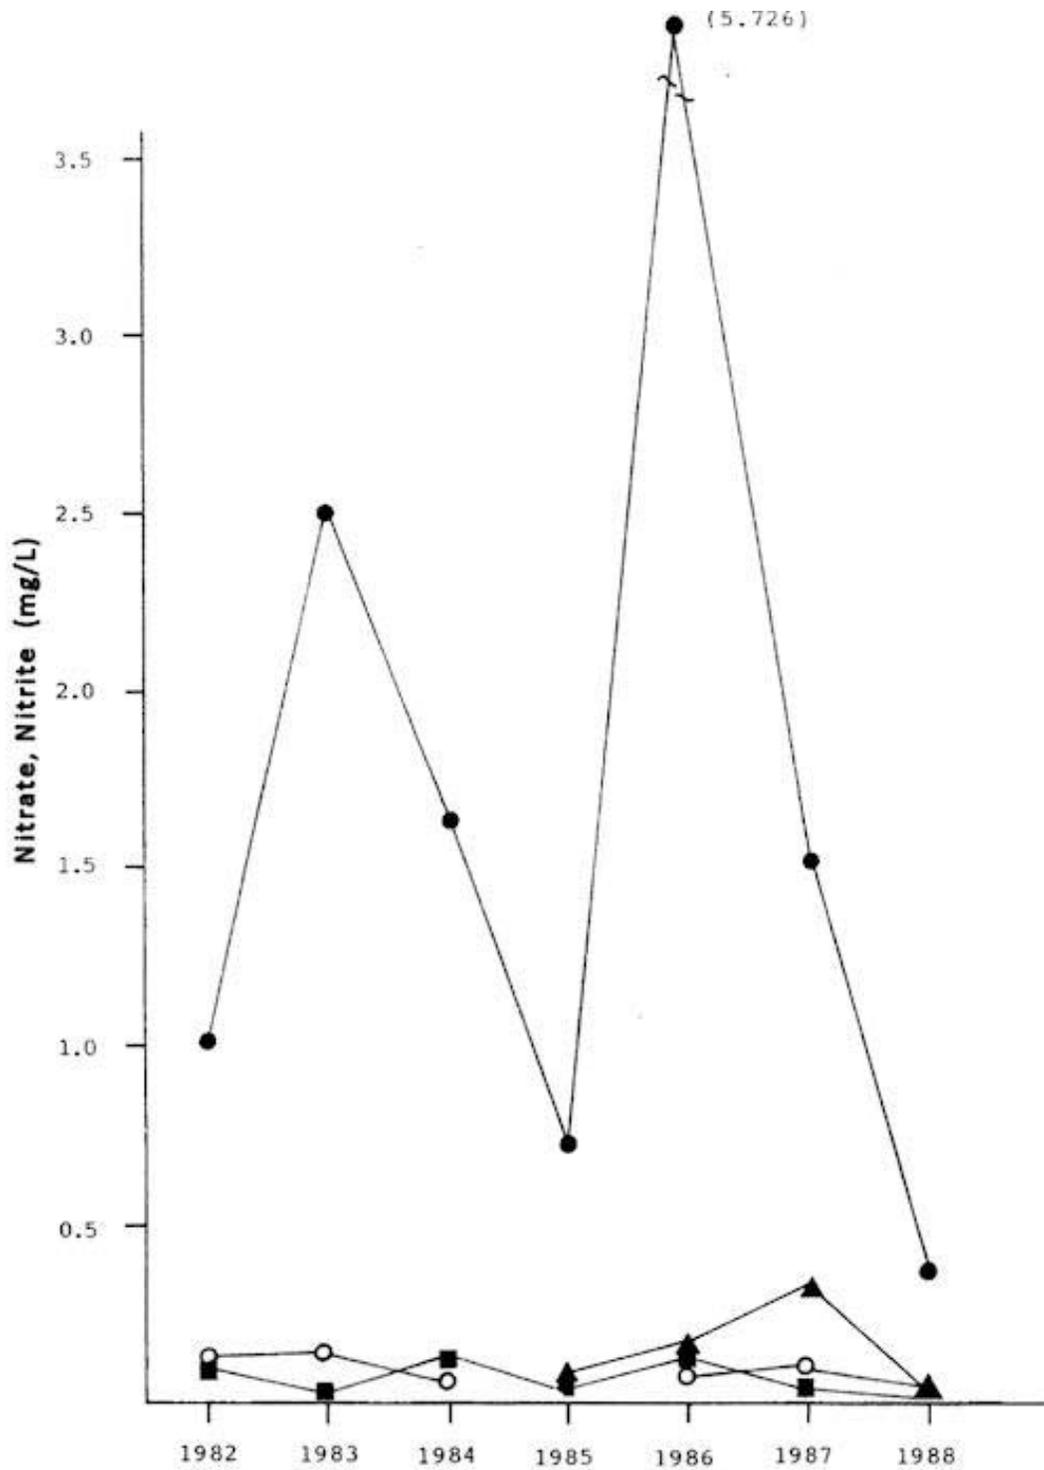
Figure 4. Nitrate, nitrite concentrations from 1982-1988 in the Maskinonge River at the Woodbine Station(▲) and Don Mills Station(■), and the Holland(●) and Black Rivers(○).

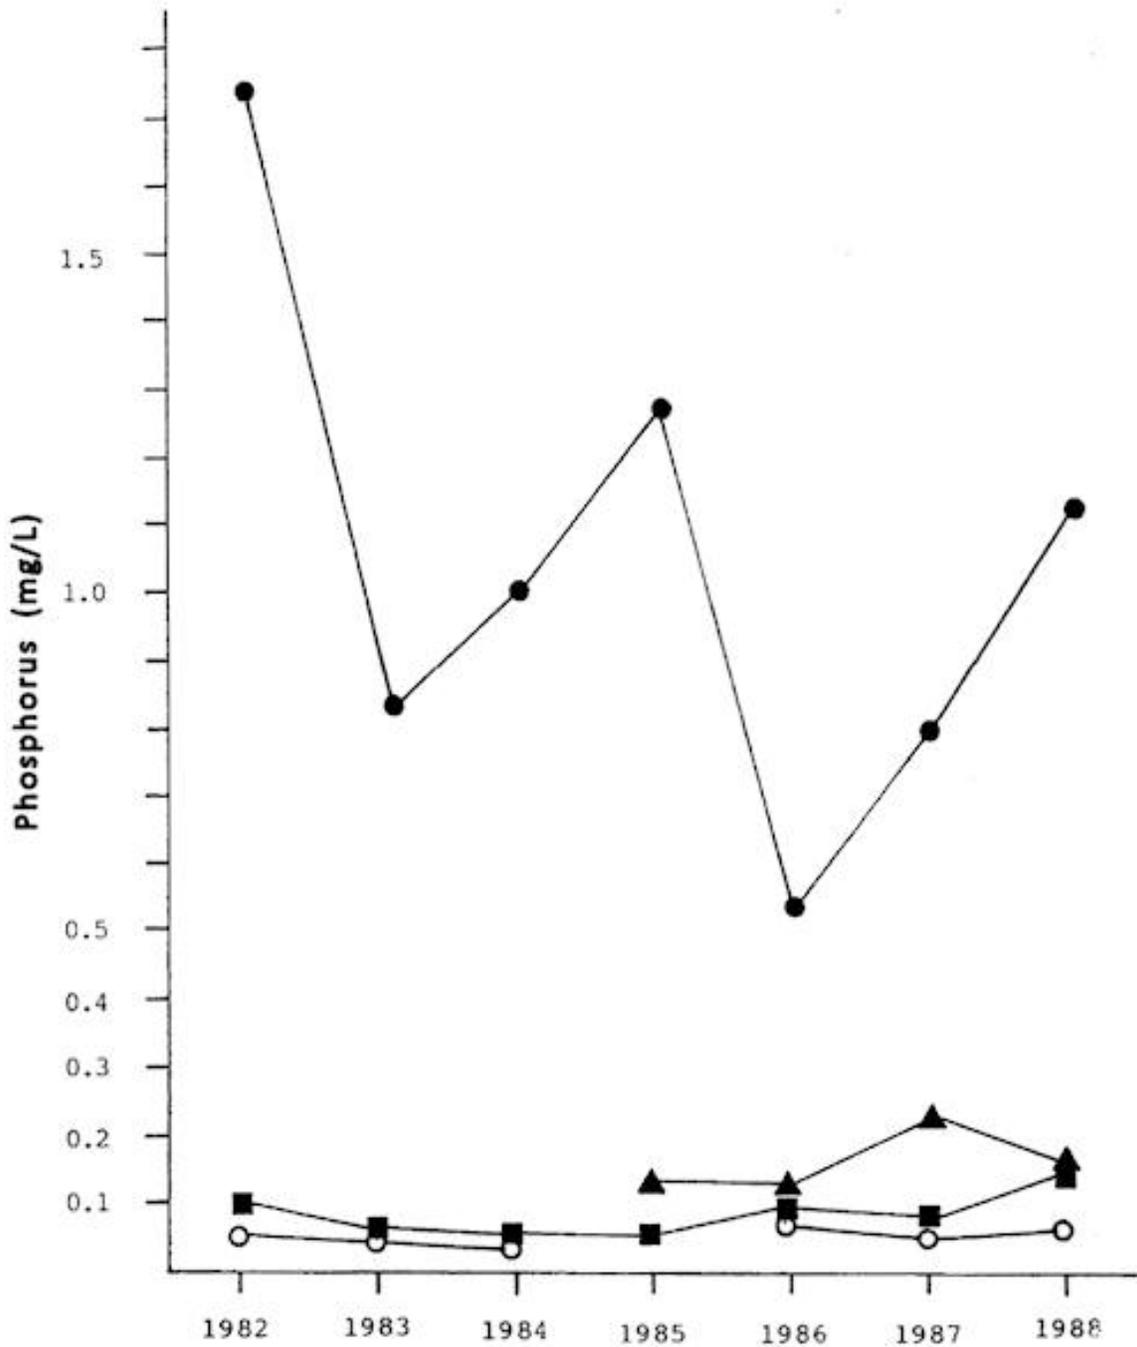
Figure 5. Phosphorus concentrations from 1982-1988 in the Maskinonge River at the Woodbine Station(▲) and the Don Mills Station(■), and the Holland(●) and Black Rivers(○).

although, phosphorus did increase from 0.074 to 0.101 mg/L from 1985 to 1986, prior to the abundant growth in 1987 Figure 5).

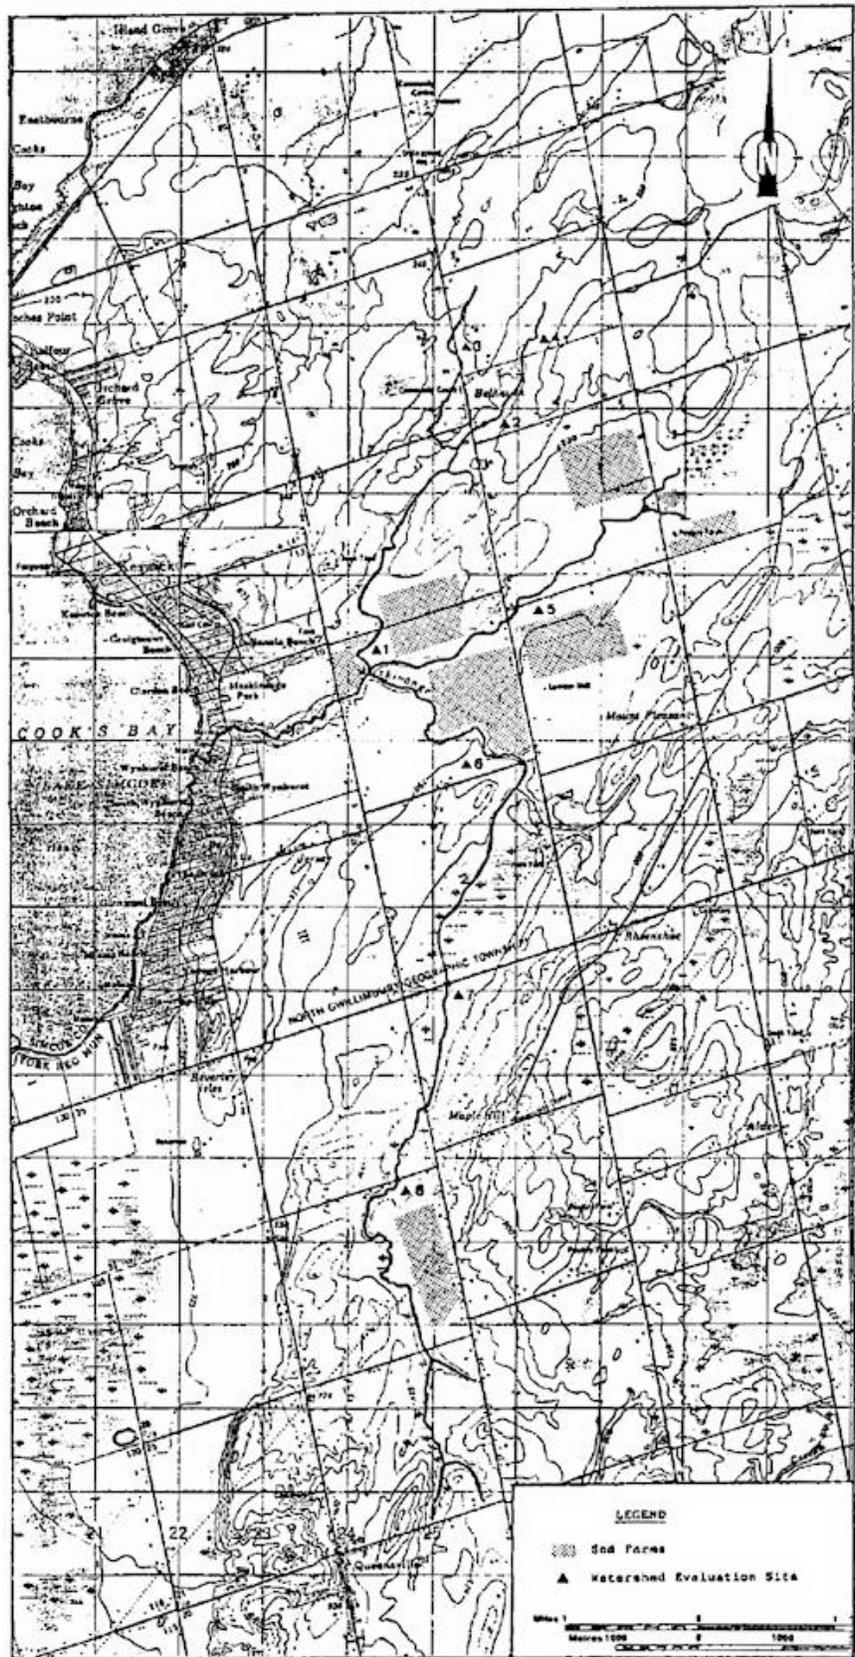
Figure 6. Maskinonge River watershed land use evaluation sites.

Tributary sites of the Maskinonge River were inspected in order to document any evident sources of potential nutrient input to the river. Eight sites were investigated Figure 6 , but no evidence or signs of nutrient input in the near vicinity of the site was observed. Due to the lack of rainfall this spring and for part of the summer, most of the tributaries were dry or had very little running water. The stream at site 6, immediately adjacent sod fields, was choked to the surface with healthy, robust, Canada Waterweed (*Elodea canadensis*) which restricted water flow. Approximately 50% of the stream surface at this site was covered with duckweed, suggesting nutrient enrichment.

Only one site specific source of potential nutrient input to the river was observed. At site 5, a large manure pile was located immediately adjacent to the stream. Since there was no water flow through the site at this time there was no evidence in the stream that this source had contributed to the nutrient availability ie. algae, duckweed growth. However, some nutrient input from this source would be anticipated during a growing season of normal rainfall levels.
