Leaking of Liquid Manure Storages - Literature Review

Ron Fleming, Jennica Johnston, Heather Fraser

Ridgetown College - University of Guelph
Ridgetown, Ontario
N0P 2C0

Ontario Pork

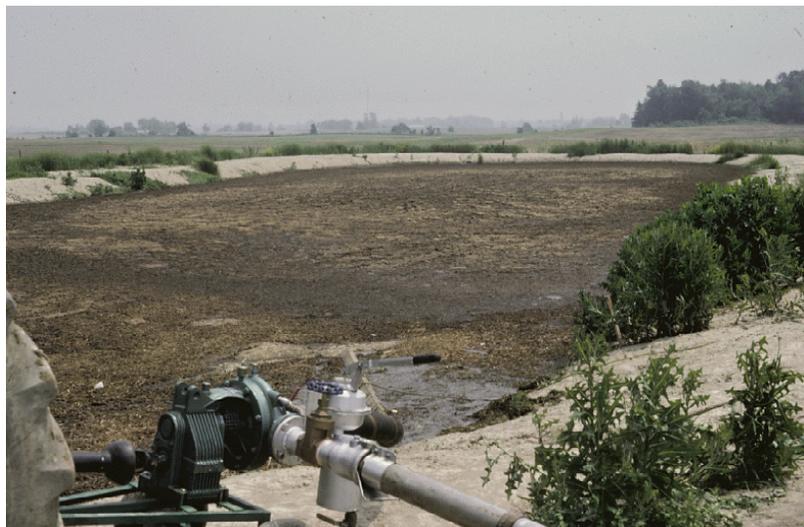
Figure 1 Earthen manure storage during pump-out

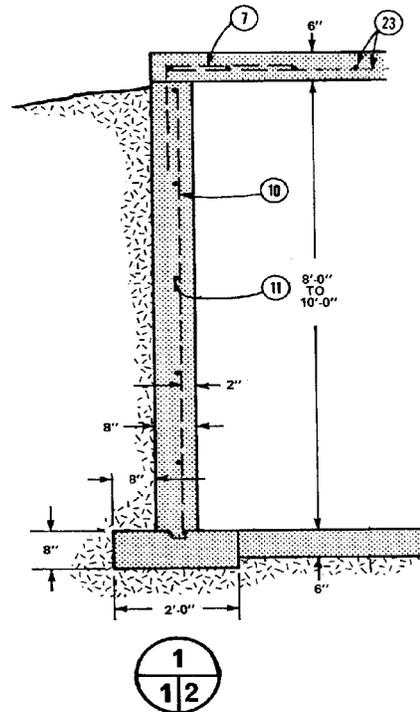
Figure 2 Detail from Canada Plan Service Plan 8712 showing cross-section of in-ground concrete tank with typical wall, footing, floor, and roof details

Most concrete tanks in Ontario are circular. Covered rectangular tanks are becoming more popular also, where the cover consists of a concrete top or a barn. The designer is responsible for making various assumptions about loadings on the concrete walls. This has led to a variety of designs for concrete tanks over the years. Researchers occasionally fine-tune the assumptions used in the design of these tanks. Jofriet et al. (1996) discussed structural design of liquid manure tanks. In their paper, they have attempted to clarify the hoop tension for different wall geometries. An example of a concrete wall structural detail is shown in Figure 2. A more up-to-date design is shown in Figure 3. Figure 3 shows a pressure relief plug in the tank floor and shows the joint sealer used at the base of the wall to ensure a leak-proof construction.

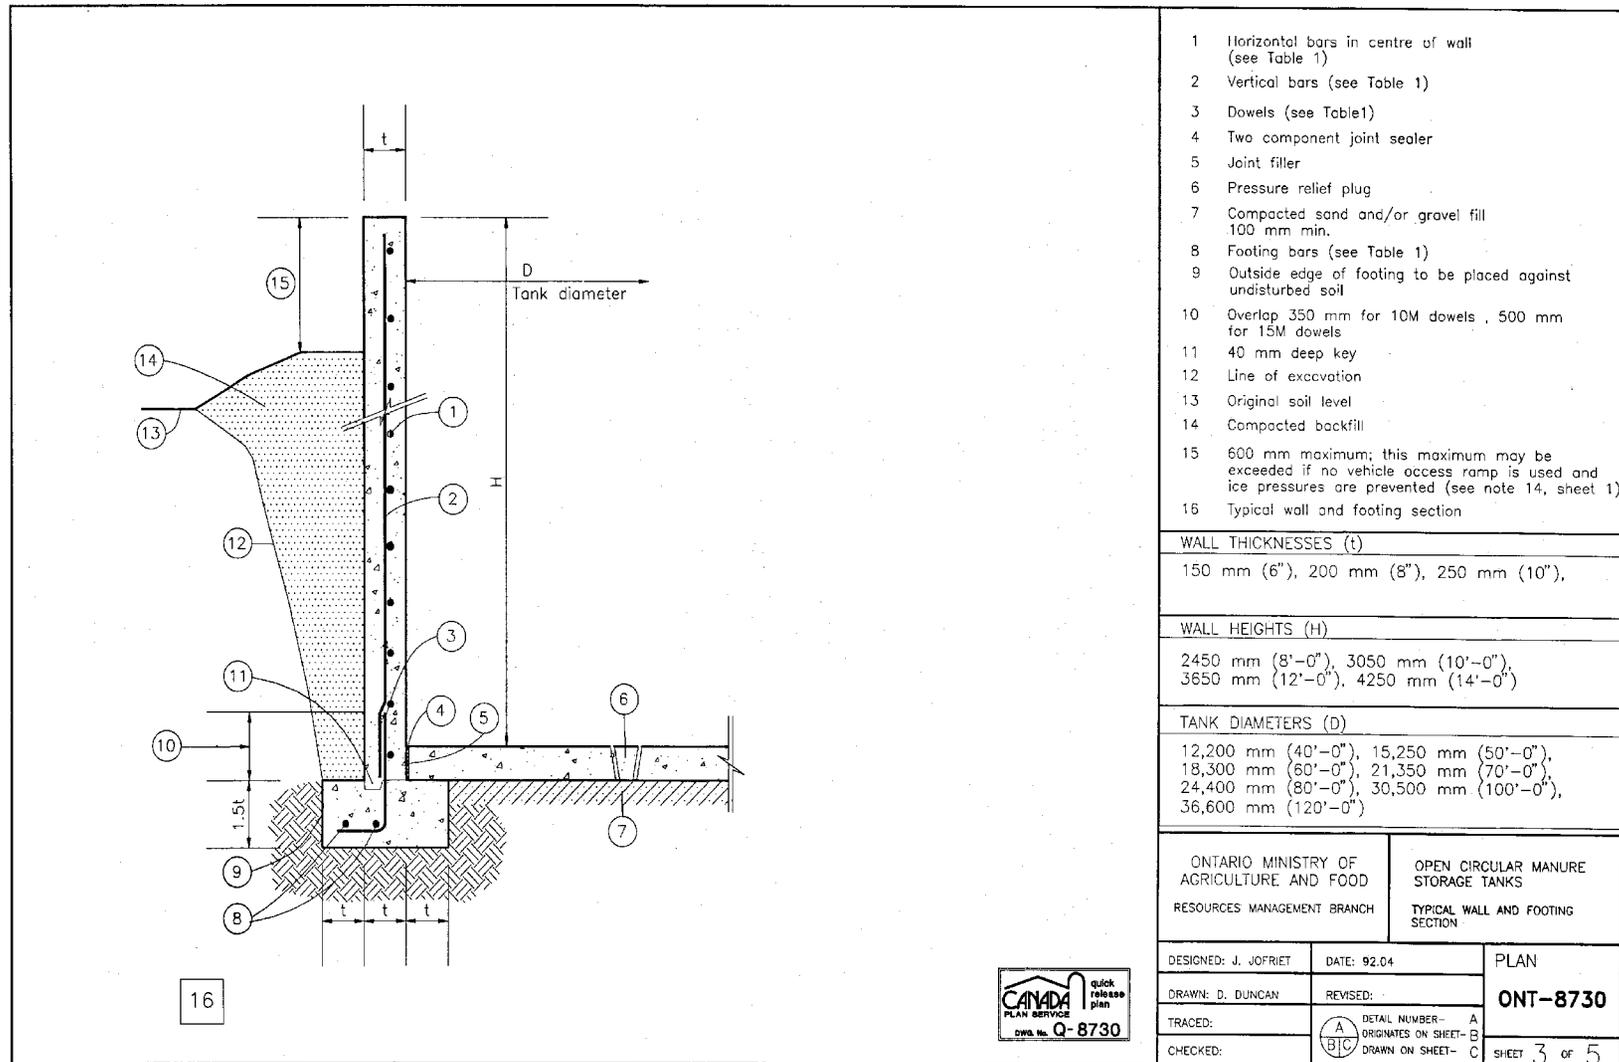
Figure 3 Tank wall detail from Plan ONT-8730 showing wall, footing, floor (1992)

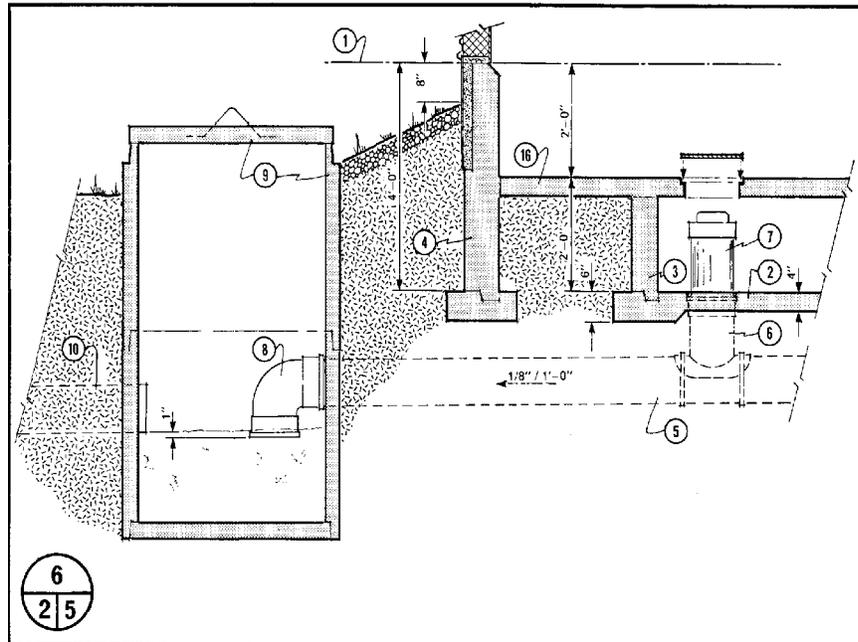
Figure 4 Detail from Canada Plan Service plan 3303 showing Saddle-T pipe connection (item 6) and horizontal drain pipe (item 5) in flush gutter system

2. A saddle-T connector. A hole is cut into the top of the horizontal pipe and the saddle-T sits over the hole. It is fastened into place with steel bands, and caulking should be applied to prevent leaks. Figure 4 shows an example of a flush gutter system found in a Canada Plan Service barn plan. The saddle-T connector, designated by item 6 on the drawing, is shown.
