# Appearance of liquid manure in water at various dilutions

Ron Fleming, Jared VandeWeghe, Malcolm MacAlpine  
Ridgetown College - University of Guelph  
Ridgetown, Ontario, N0P 2C0  
July, 2003

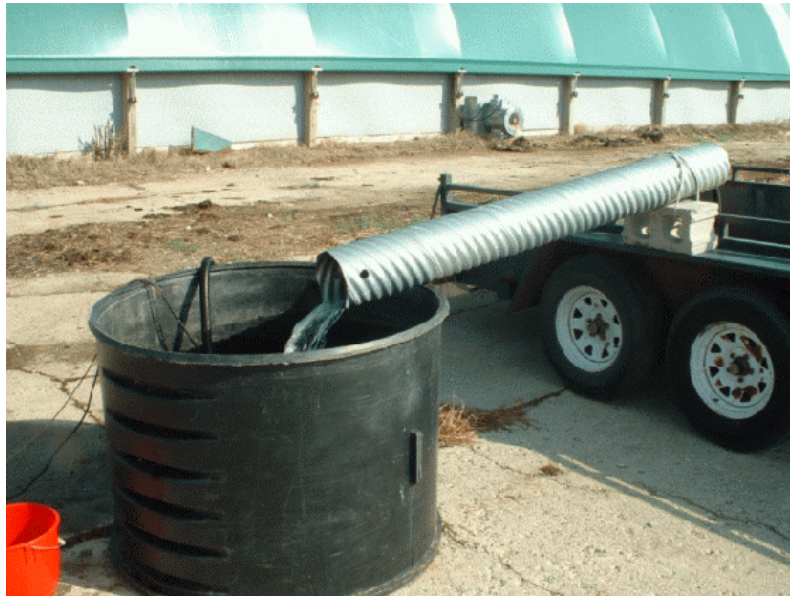
**Figure 1** Test setup at Ridgetown College

A test facility was set up at Ridgetown College. It consisted of a length of corrugated steel drainage pipe (similar to a tile outlet), a large plastic tub and a pump. The test setup is shown in Figure 1. On August 12, 2002, 400 L of tap water (municipal supply) was

This manure/water mixture was pumped through the pipe. At the pipe outlet, the liquid dropped into the receiving tank and the pump kept the liquid circulating. Samples were collected at this outlet pipe end and photos were taken. The samples were analyzed for turbidity (APHA test 2103, performed at Envirotest Labs), pH, conductivity and concentrations of nitrate-N, ammonium-N, and *E. coli* bacteria (all performed at Lab Services, University of Guelph). In addition, conductivity was measured on site using two

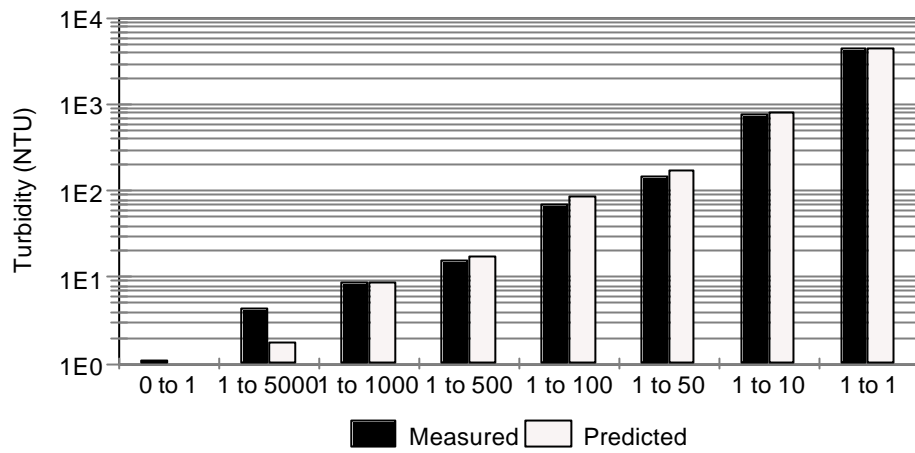
**Figure 3** Measured and predicted turbidity levels in various manure/water solutions

**Turbidity** – While turbidity may be detected with the naked eye, there are test methods that can accurately measure this property. Similar to ammonium, there was very good agreement between the measured values and those predicted (based on the concentration found at the 1:1 dilution). Figure 3 shows this relationship. Once again, the y-axis is a log scale, to make interpretation easier.

For measurement of tile water turbidity, it is important to know the levels in background samples. Values may be affected by soil organic matter levels, flow rate in the tile, temperature, and other factors.

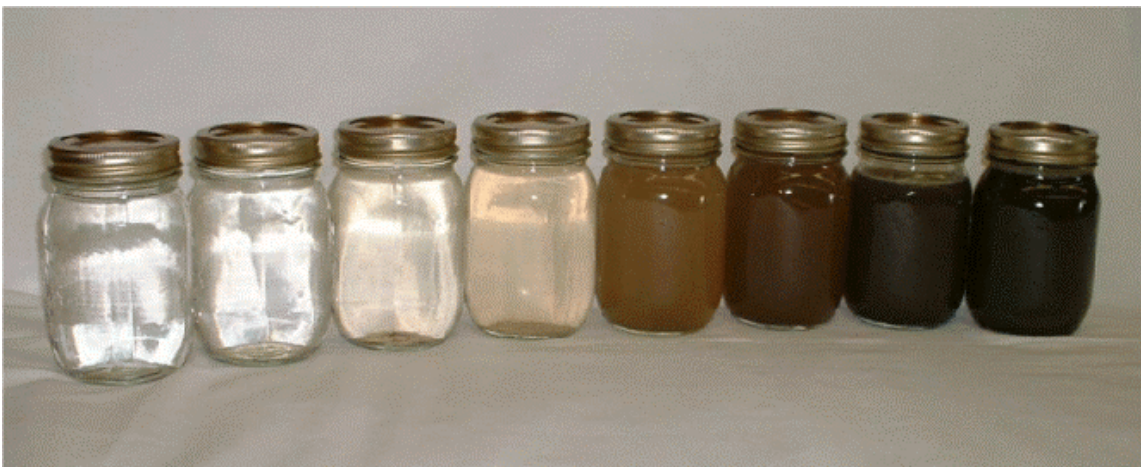
**Figure 4** Manure/water solutions at varying ratios – (left to right) 0:1, 1:5000, 1:1000, 1:500, 1:100, 1:50, 1:10, 1:1

The samples collected during this test were placed in clear glass bottles and photographed against a white background. The goal was to prepare reference photos to allow for estimations of manure concentrations in water. Figure 4 shows the group of bottles (best viewed in colour). For clean non-turbid water, such as was used in the test, it seems reasonable to conclude that concentrations of 1:500 to 1:5000 (manure:water) may be detectable by the naked eye. A close-up of the 1:500 dilution as it flows from the tile outlet is shown in Figure 5.

- Manure in water at a ratio of 1:5000 was barely visible when the initial water was clear. Concentrations of 1:500 should be visible in most cases. It is therefore possible that water could contain unacceptable levels of manure-sourced bacteria even though it appears to be clear.
- Turbidity and ammonium in water appear to be better indicators of trace amounts of manure contamination than nitrate-N, electrical conductivity or pH.
- In order to use these tests, there must be some way to measure levels in “background” water samples.
