Ridgetown College Compost Project Photo Gallery

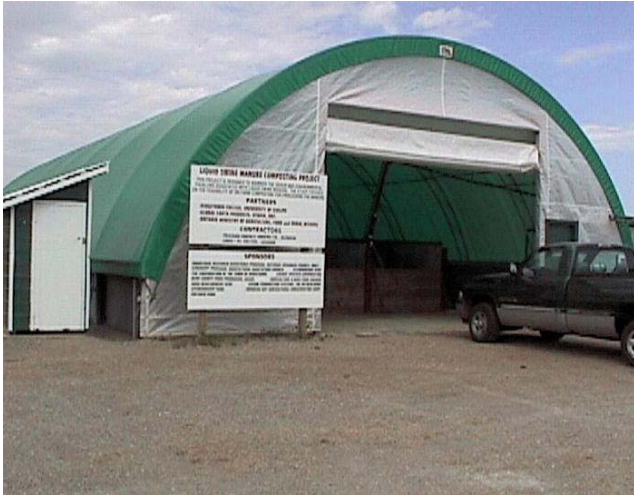
Figure 1. Building housing the compost channels and mechanical turner.

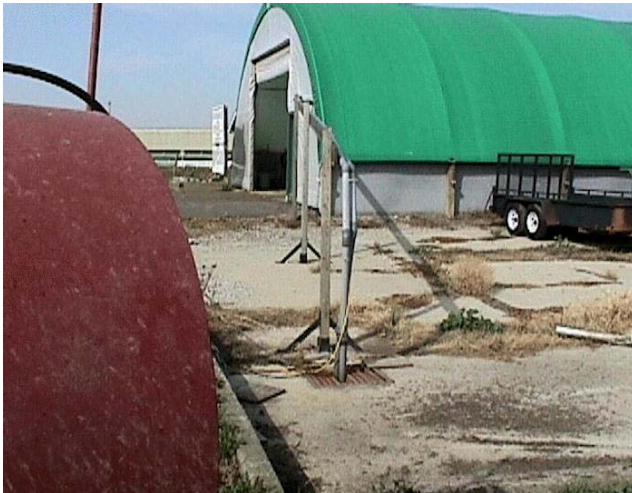
Figure 2. Liquid manure stored in underground tank near compost building - pumped to turner as needed - drainage liquid was returned to this storage.

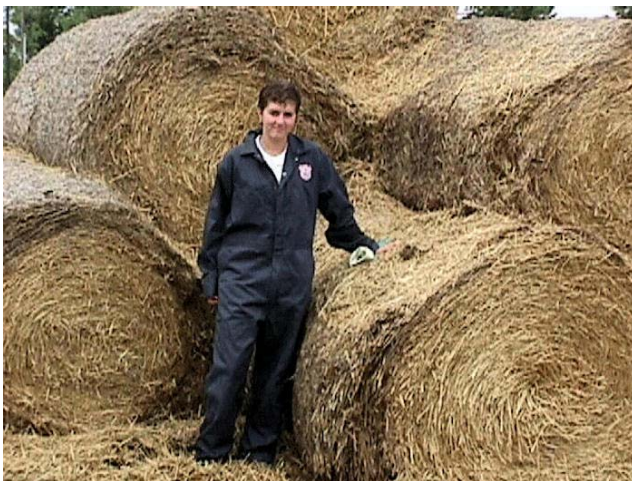
Figure 3. Straw bales used in compost process.

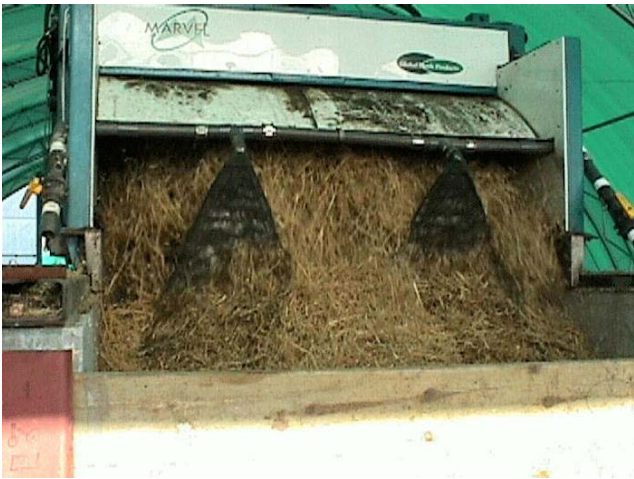
Figure 4. Applying liquid manure to straw while turning.

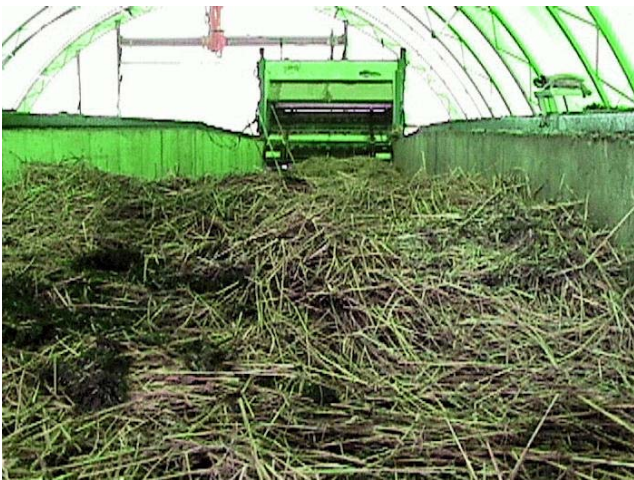
Figure 5. Turner in channel after heating has started and some settling of straw.

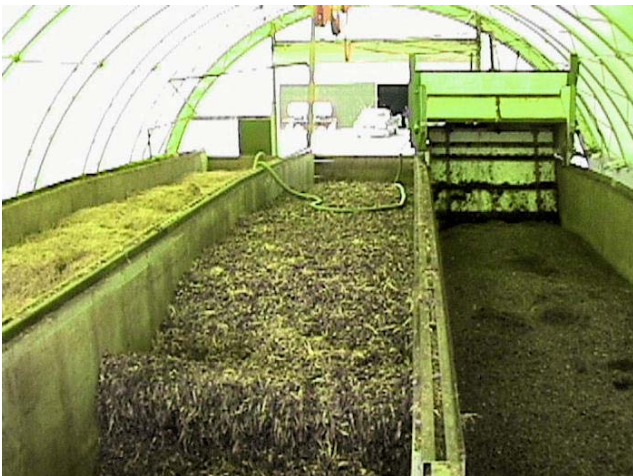
Figure 6. Overview of 3 channels - showing different carbon materials: straw, corn stalks and wood fibre.

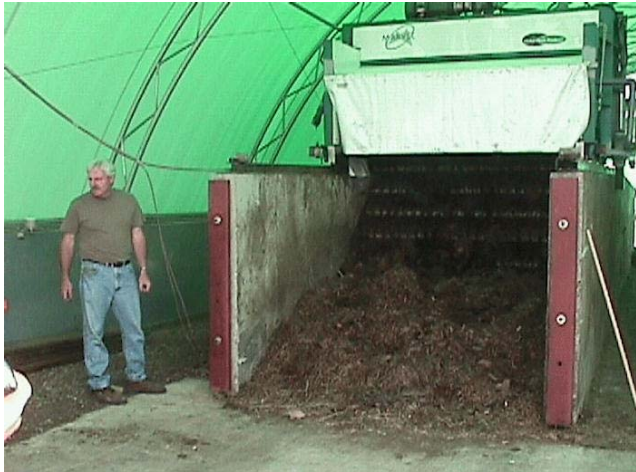
Figure 7. Turner at end of channel - partly composted straw + pig manure.

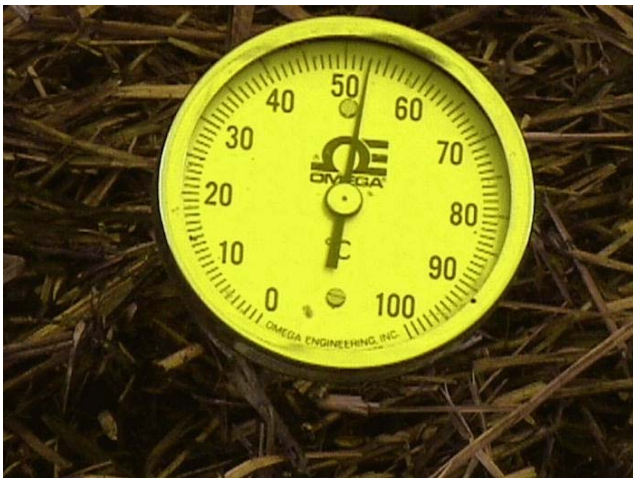
Figure 8. Thermometer showing typical temperature reached after 2 days - usual range is 55 to 70°C from day 3 to about day 14.

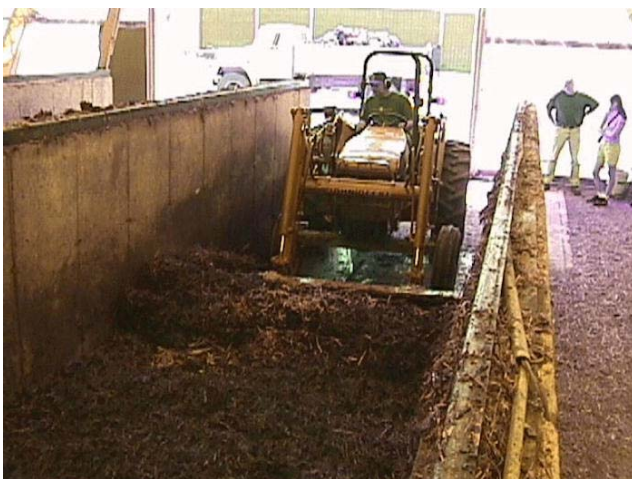
Figure 9. Removing partially finished compost from channels at about the 14-day stage - prior to the "curing" stage.

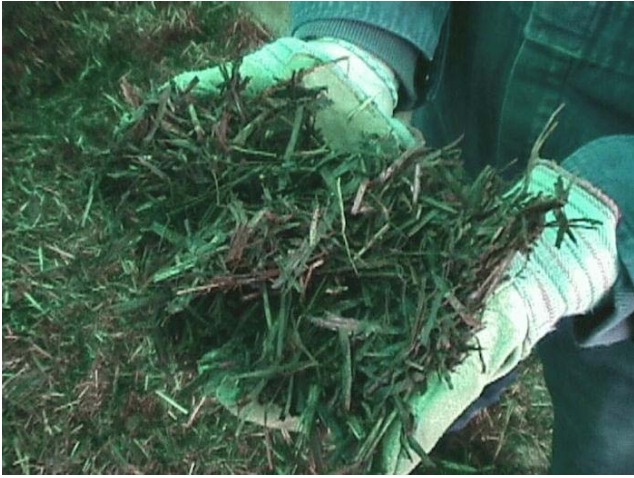
Figure 10. Compost as it comes out of the channels, before the curing stage - this was made using straw.

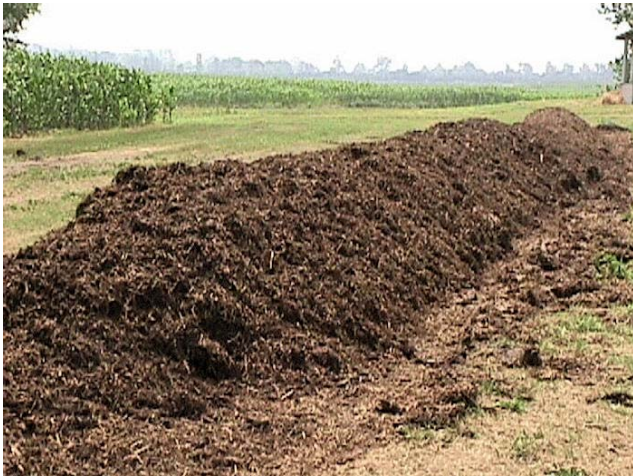
Figure 11. Curing pile - in this case, the pile is in the shape of a windrow, but that is not necessary. Curing is usually complete when the total compost time is about 12 weeks.

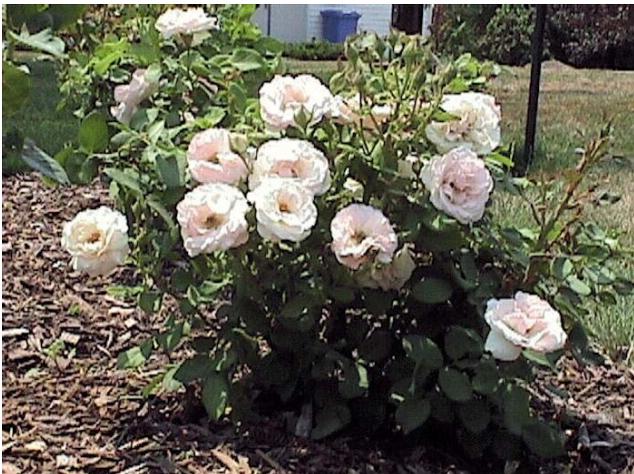
Figure 12. Finished compost, made using wood chips, was used as a garden mulch in several flower beds at the college. The wood took longer to break down, but made a good mulch product.
